## **TECHNO-ECONOMIC ASSESSMENT STUDY FOR ROGUN HYDROELECTRIC CONSTRUCTION PROJECT**

### **PHASE 1 ASSESSMENT OF EXISTING ROGUN HPP WORKS**

#### **Annexes**

**Report No. P.002378 RP 39 rev. C**

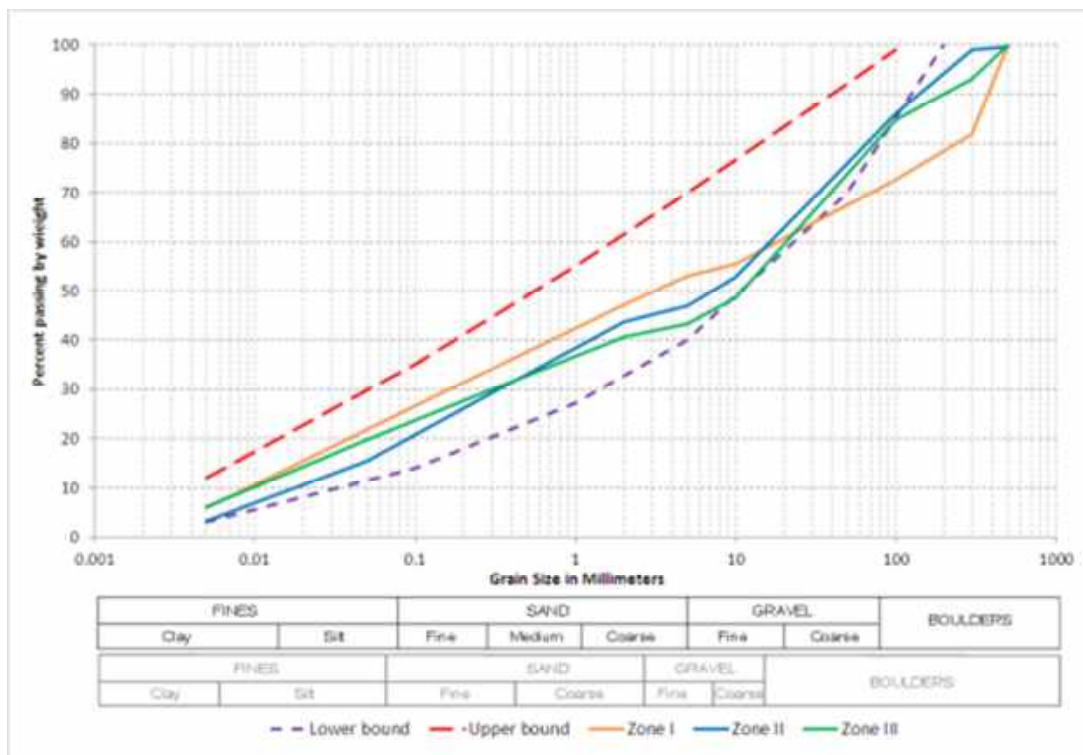
**Figure 6-15: Design grading curves for core materials and average composition for each zone of borrow area 17**

As stated before, Zone III presents excessive content of gypsum (6%, i.e. about ten times more than in areas I and II), which discarded its usage as materials for the dam.

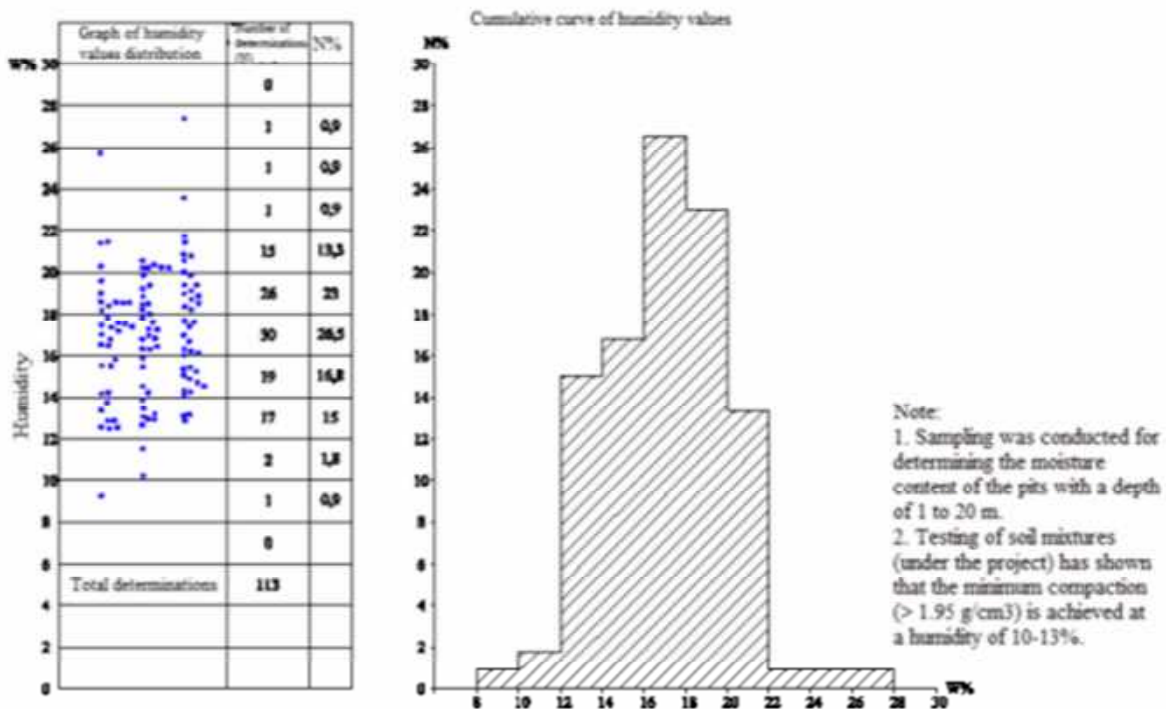
**Figure 6-16: Results of moisture levels determination on borrow area 17 (1/2)**

A system of drainage of the deposited materials is being considered as a remedial process, but needs more studies, as well as on-site verification before being validated.

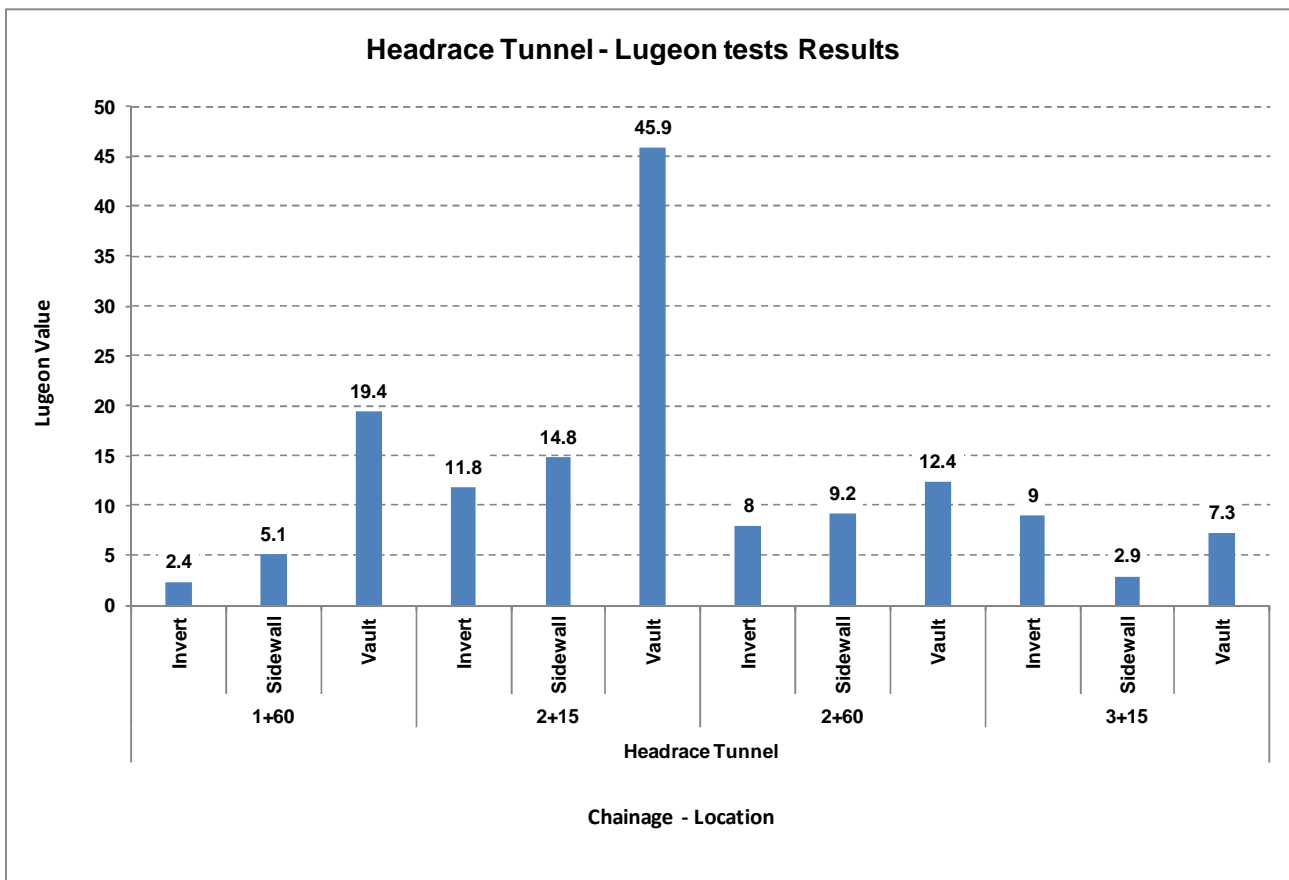
The following graph summarizes the tests results on the temporary headrace tunnel:

After having checked the recorded Lugeon Values it is evident that additional grouting is to be envisaged in the stretch between chainage 1+60 and 2+60; this intervention is further justified taking into account the trend evidenced by the Lugeon test cycle (chainage 2+15 – Invert) that shows wash-out behavior upon water pressure and flow application: this tendency in absence of any treatment would lead to increasing the permeability of the rock mass during tunnel operation with general worsening of tunnel behavior in relation with the points mentioned at the beginning of par. 4.2.5.

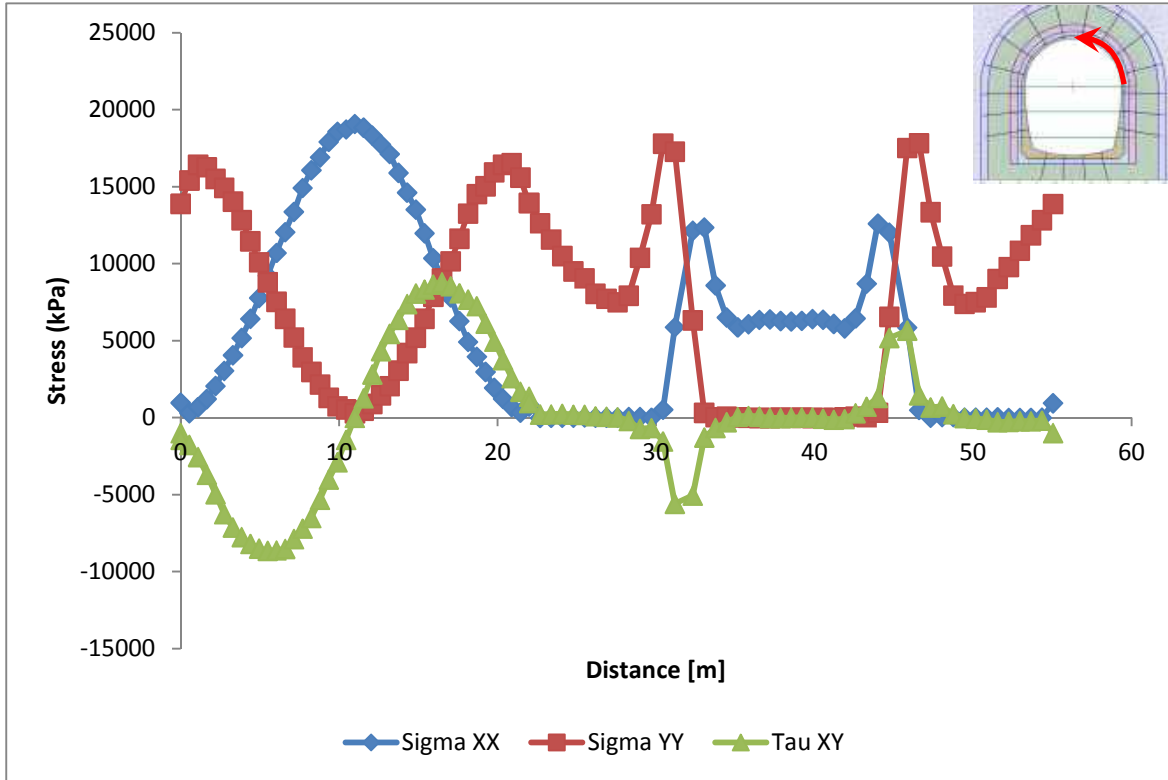
It is noted that at the end of the simulation stages some localized zones of failure occur in the unreinforced 1.0 m thick lining, with the rock mass around the tunnel being in a plastic state both at the sidewalls and invert. The state of stress in the existing reinforced concrete lining is shown in Figure 21 by plotting the normal and shear stresses.

Figure 21: Normal and shear stresses in the existing reinforced concrete lining, starting from right first point of crown arch, counter clockwise ( $K_h = 0.8$ , see Appendix 1 for  $K_h = 0.2$  and  $1.5$ ).

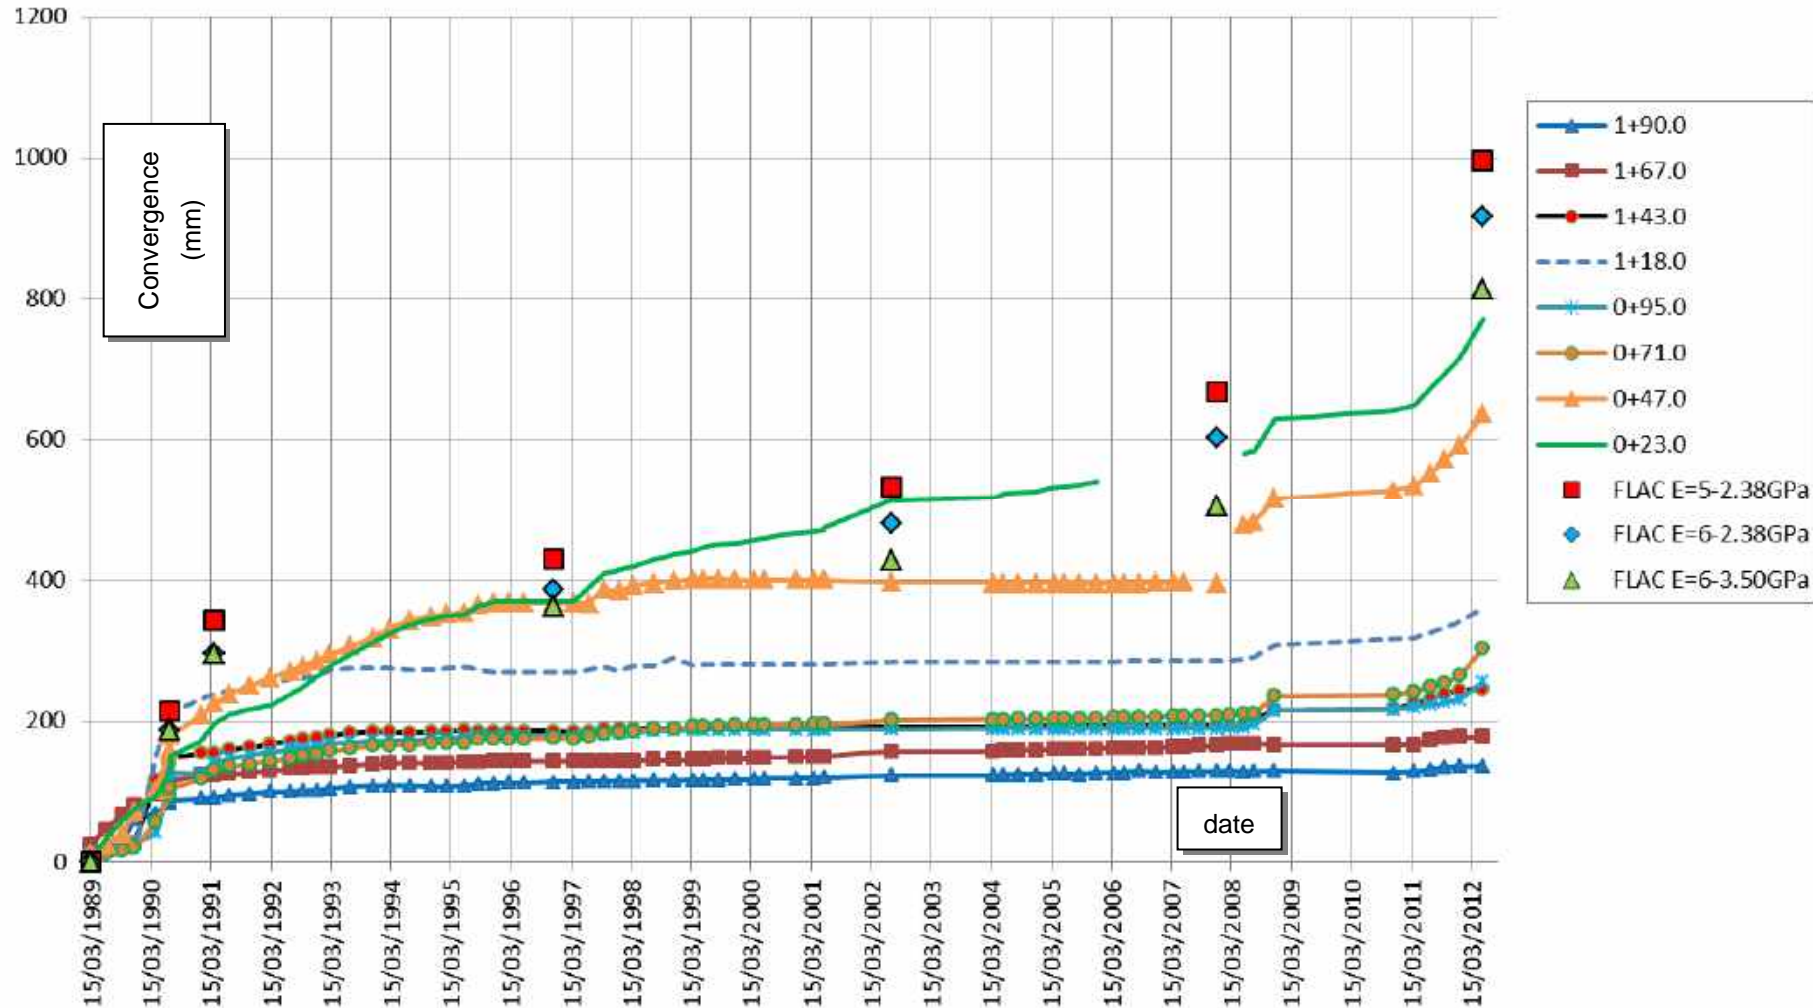
Figure 25: Computed and monitored convergence history from 1989 to 2012 at elevation 986 m in the MH cavern. The vertical axis gives the convergence values (computed and monitored) in mm. The horizontal axis shows the corresponding time when a measurement is taken

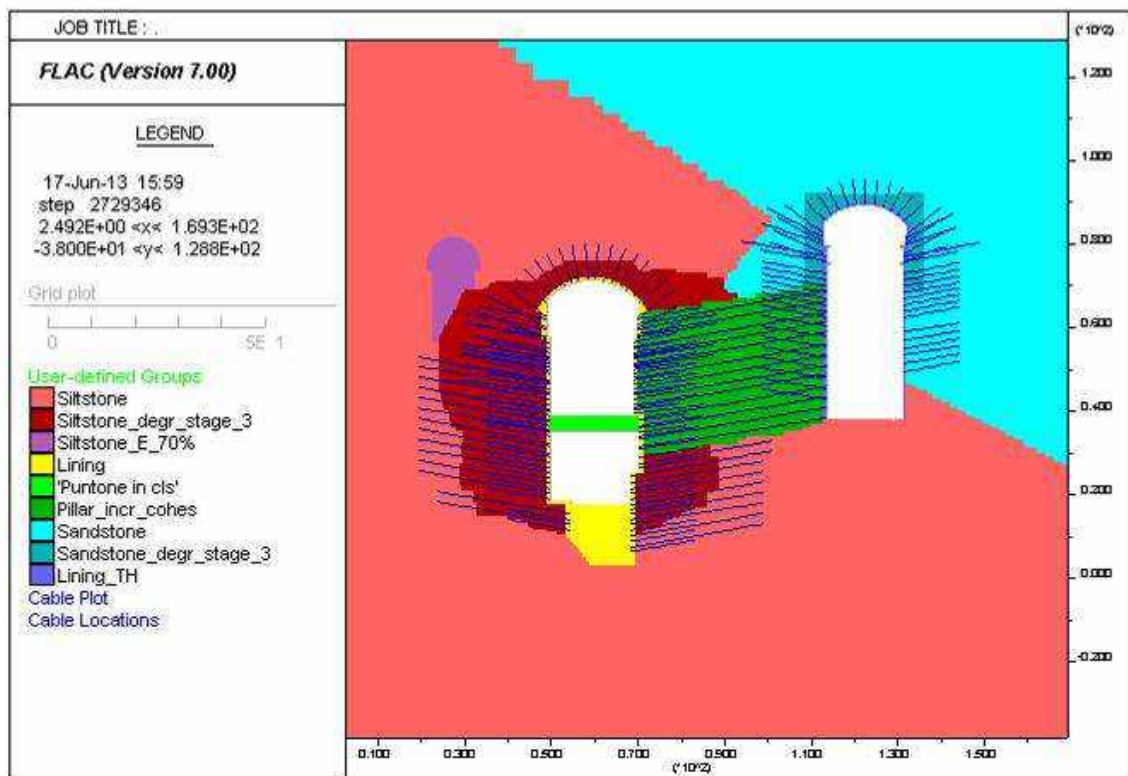
Figure 41: Illustration of the suggested reinforcement stabilization measures superposed on the FDM grid used for modelling purposes.

According with the above line of thoughts, Figure 41 illustrates the reinforcement and stabilization system which is envisaged in order to improve the present stability conditions of the underground cavern complex. This system is superposed on the FDM grid that will be used to perform some preliminary numerical analyses which are intended to describe the beneficial effects that can be achieved.

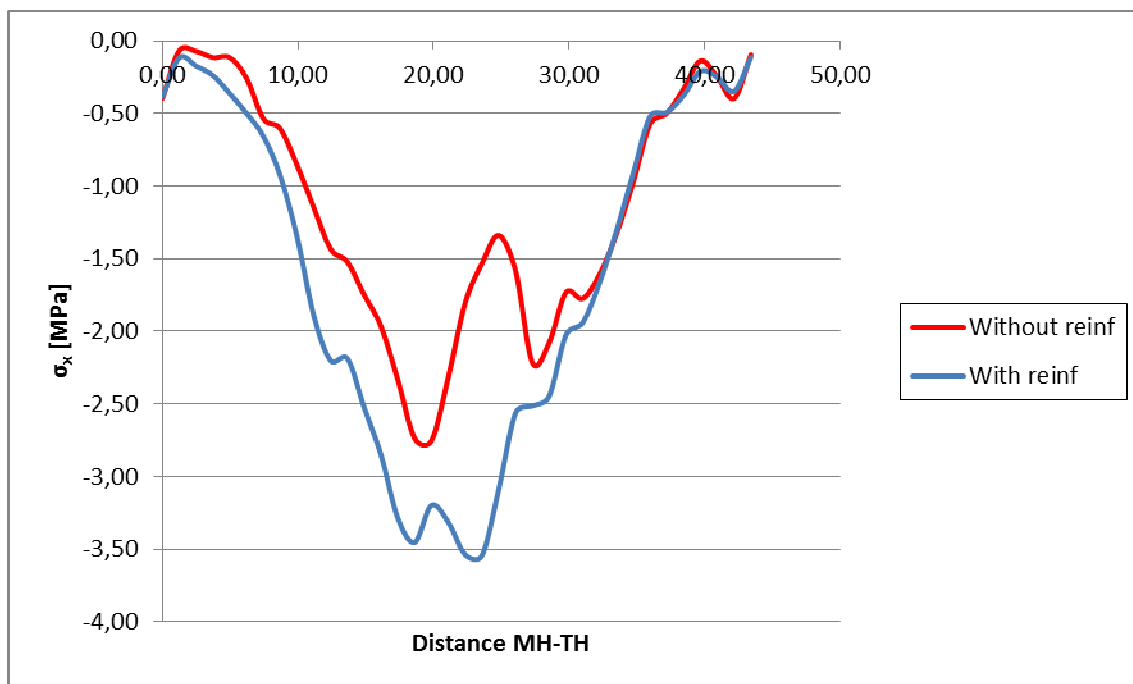
It is of interest to note that with the applied reinforcement and stabilization measures, a more favorable distribution in the state of stress in the pillar between the two caverns takes place with an increase in the confinement action (Figure 42). In terms of convergence values, the computed convergence at elevation 986 m results to be equal to 80 mm with respect to the 140 mm predicted with the reinforcement as in the present design (Figure 43). Similarly, at elevation 958.2 m the convergence is evaluated to decrease from 225 mm down to 175 mm (Figure 44).

Figure 42: Horizontal stress in the pillar between the MH and TH caverns. Computed values “with” and “without” the reinforcement and stabilization measures shown in Figure 41
