TECHNO-ECONOMIC ASSESSMENT STUDY FOR ROGUN HYDROELECTRIC CONSTRUCTION PROJECT

PHASE II: PROJECT DEFINITION OPTIONS

Chapter 2: Geology

Part A - Assessment of geological conditions

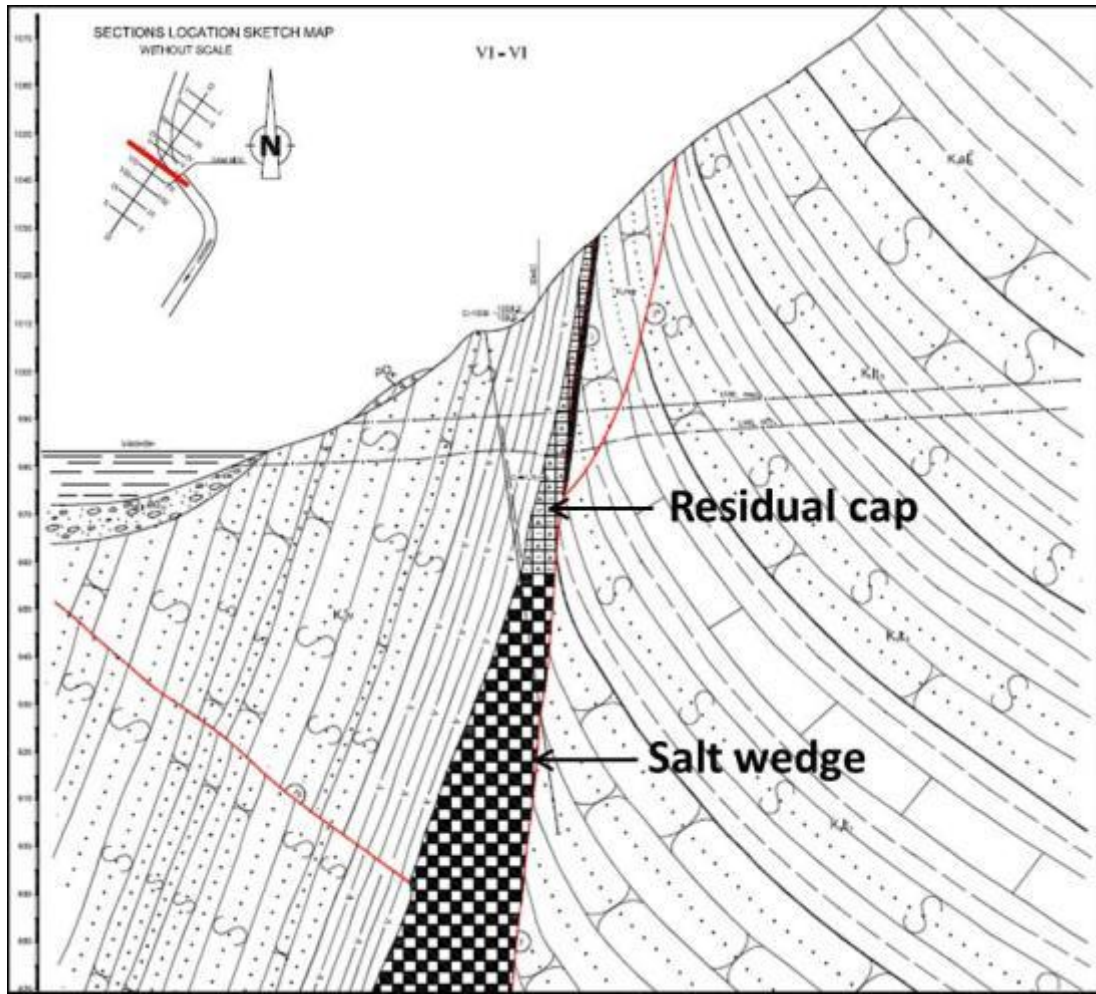
- The salt extrusion rate is in the order of 2 cm/year, that is about ten times higher than the vertical slip rate of the fault walls.
- The top of the salt wedge was found between elevations 952 and 970, with thickness in the range 2 to 12 m. It pinches out above these elevations, presumably owing to dissolution (for instance drawing 1174-03-41 in [1]).
- Above the salt wedge, the residuum left behind after the dissolution of the salt forms a cap of heterogeneous material, 10 to 12 m wide and thinning upwards. For 7-8 m above the salt, the residual cap comprises soft, insufficiently confined materials. Permeability tests showed that this particular facies could be locally highly permeable and particular treatment has been designed (HPI Moscow). (This major design topic is discussed separately.)

Illustration no. 14. Salt wedge on Ionaksh Fault in the Right Bank.

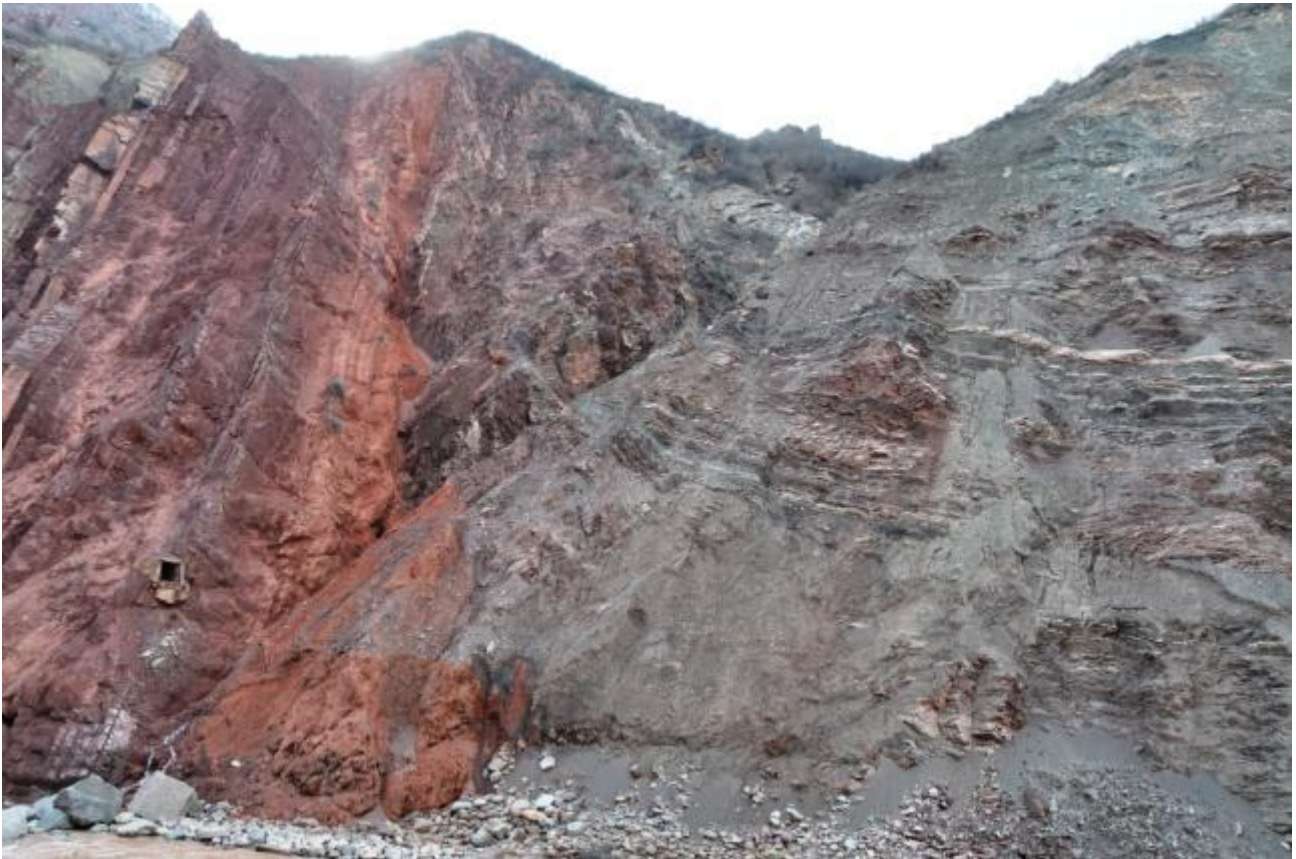
Illustration no. 17 shows the thrust fault in the Right Bank at the dam site. It is clearly outlined by the reddish strip of Upper Jurassic mudstone. In the foot wall, the SE limb of Kirbitch syncline abuts against the fault.

Illustration no. 17. Ionaksh Fault in the Right Bank.

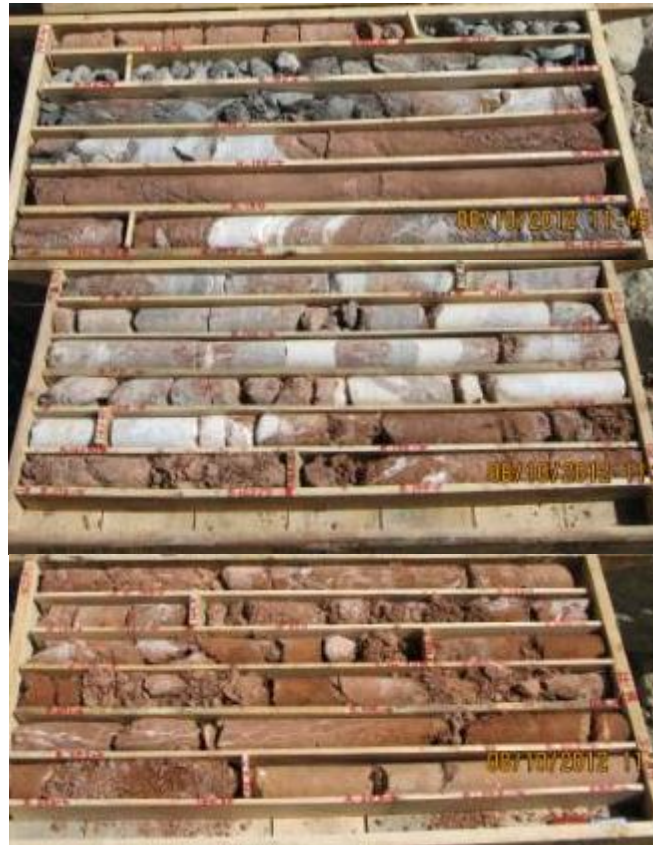
- The thickness of gypsum in the fault zone is variable, from less than 1 m to more than 5 m. It is rarely visible at surface. Illustration no. 18. Ionakhsh Fault zone in borehole WRB2 shows thick gypsum in borehole WRB2. Very likely, the same thick, disturbed gypsum lens is also visible at outcrop in the road cut near the borehole (Illustration no. 19 for photograph and Illustration no. 20 for the geophysical profile across this lens). The presence of this thick lens coincides with the area of bending of the structures from normal to overturned position, which suggests that such thickness is local but can occur in special settings.

Illustration no. 18. Ionakhsh Fault zone in borehole WRB2

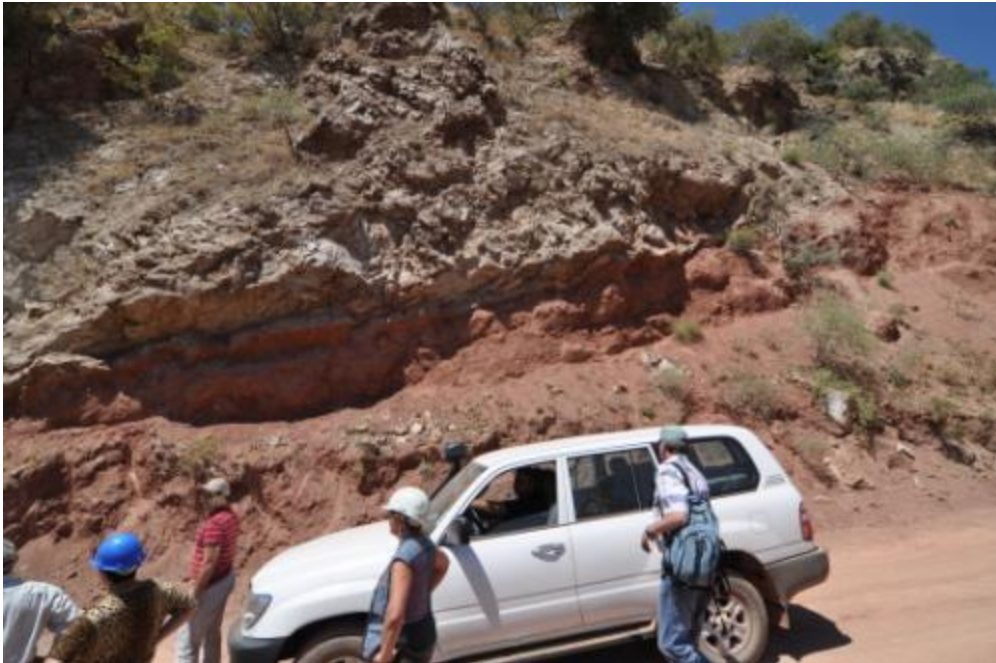
Illustration no. 19. Thick and deformed gypsum lens within Ionakhsh Fault zone,

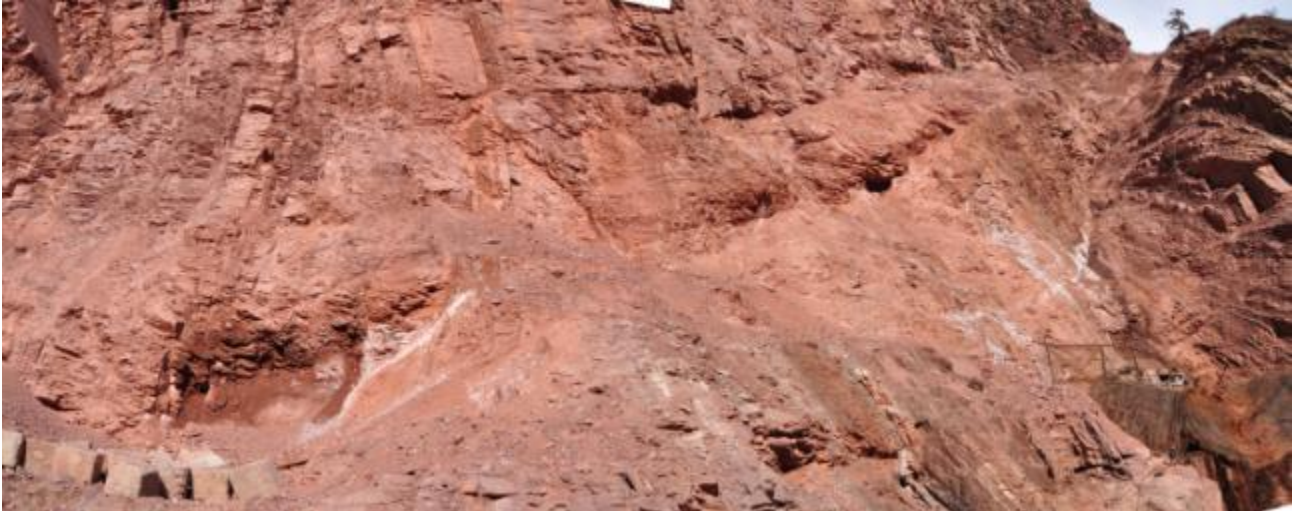
According to [1], the cumulative offset of this fault is 120 m. In both banks, the fault comprises two branches, the width of the tectonic wedge being of 60-70 m. The same width is assumed near the foundation of the underground caverns ([1]). Field observations suggest that the maximum offset

could attenuate significantly along the strike of the fault, in particular in the RB of the dam. Illustration no. 22 shows the fault in the Left Abutment. Tectonic lenses including highly sheared materials are several meters wide. In the Right Abutment, the two branches of the fault are more like a saw-cut, delimiting a wedge with increased fracturing degree but no crushing zone similar to that in the opposite bank. Further towards downstream, the fault becomes untraceable when it reaches the atypical zone with overturned sequence.

Illustration no. 22. Fault #35 in the Left Abutment of the dam.

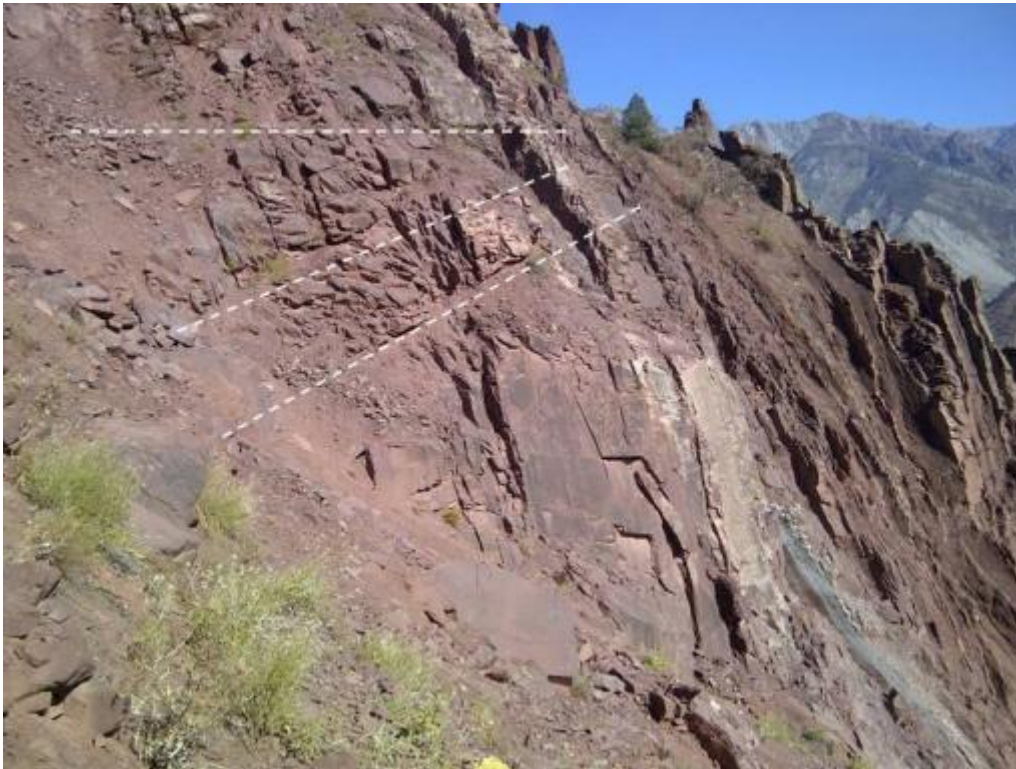
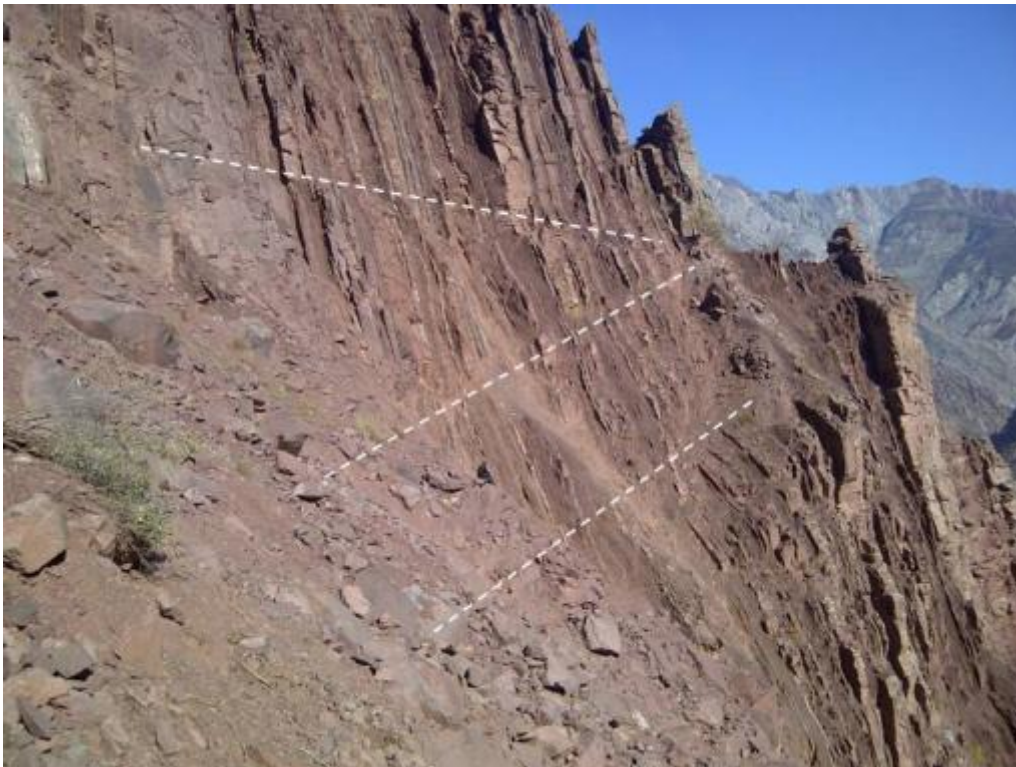
Illustration no. 27. Offsets on subhorizontal and S4 discontinuities, upper part of the downstream ridge near the boundary of the atypical zone.

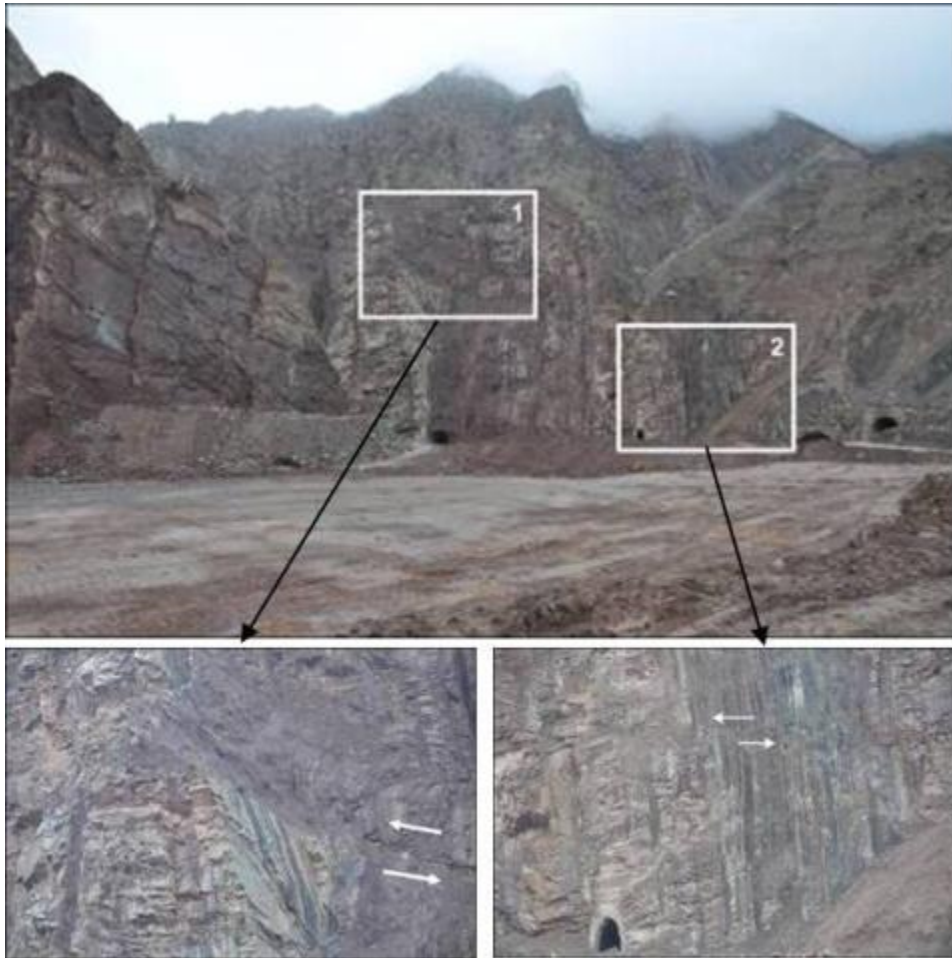
Illustration no. 28 shows very persistent subhorizontal discontinuities, which do not appear as second order offset accompanying S4 faults.

Illustration no. 28. Offsets on very persistent subhorizontal / shallow dipping discontinuities, Left Bank downstream.

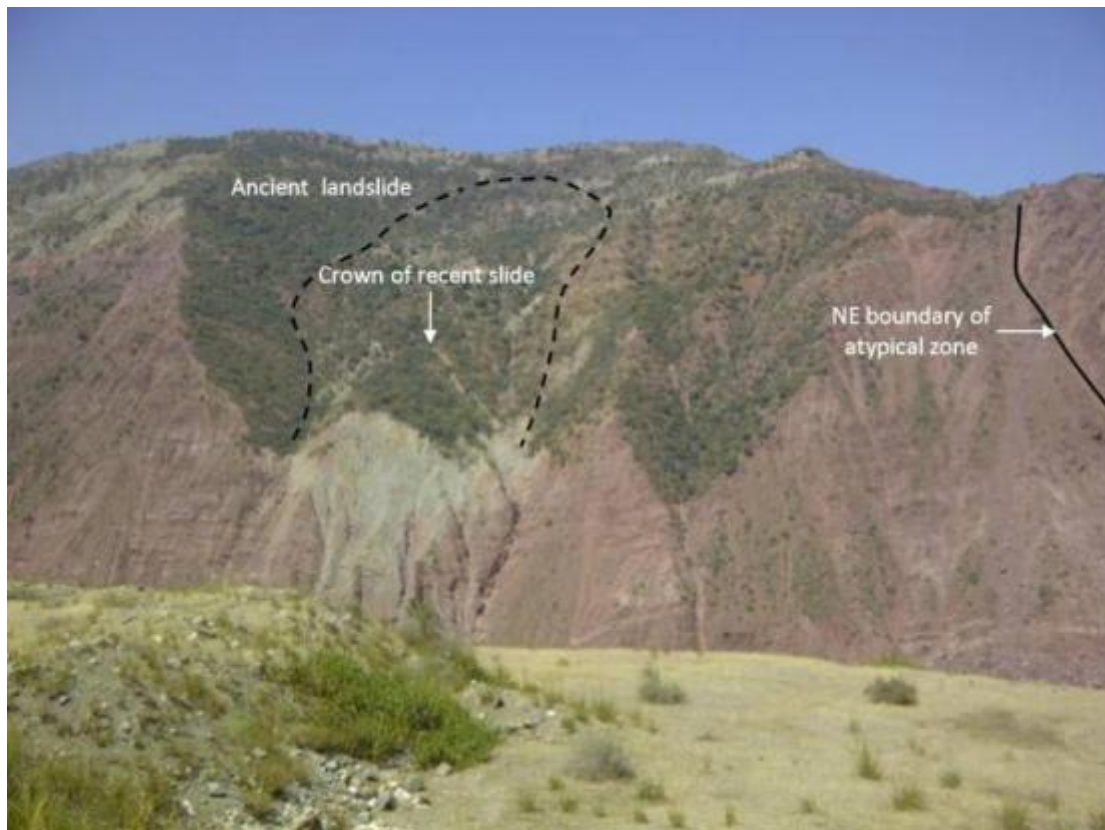
Illustration no. 32. Ancient landslide in the central part of the atypical zone.

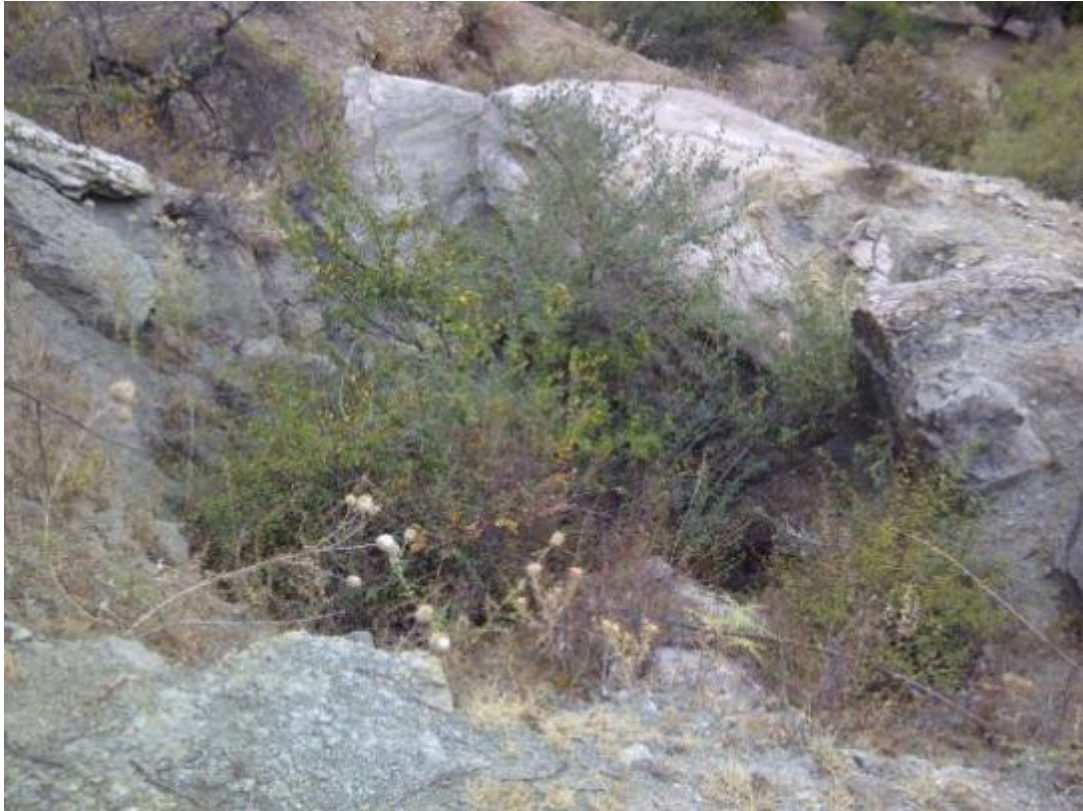
- Some of the Upper Cretaceous formations identified in the Ararak stream were found to include thick gypsum layers which exhibit numerous karst dissolution features (Illustration no. 35)

Illustration no. 35. Sinkhole in thick gypsum layer, left bank of Ararak stream.

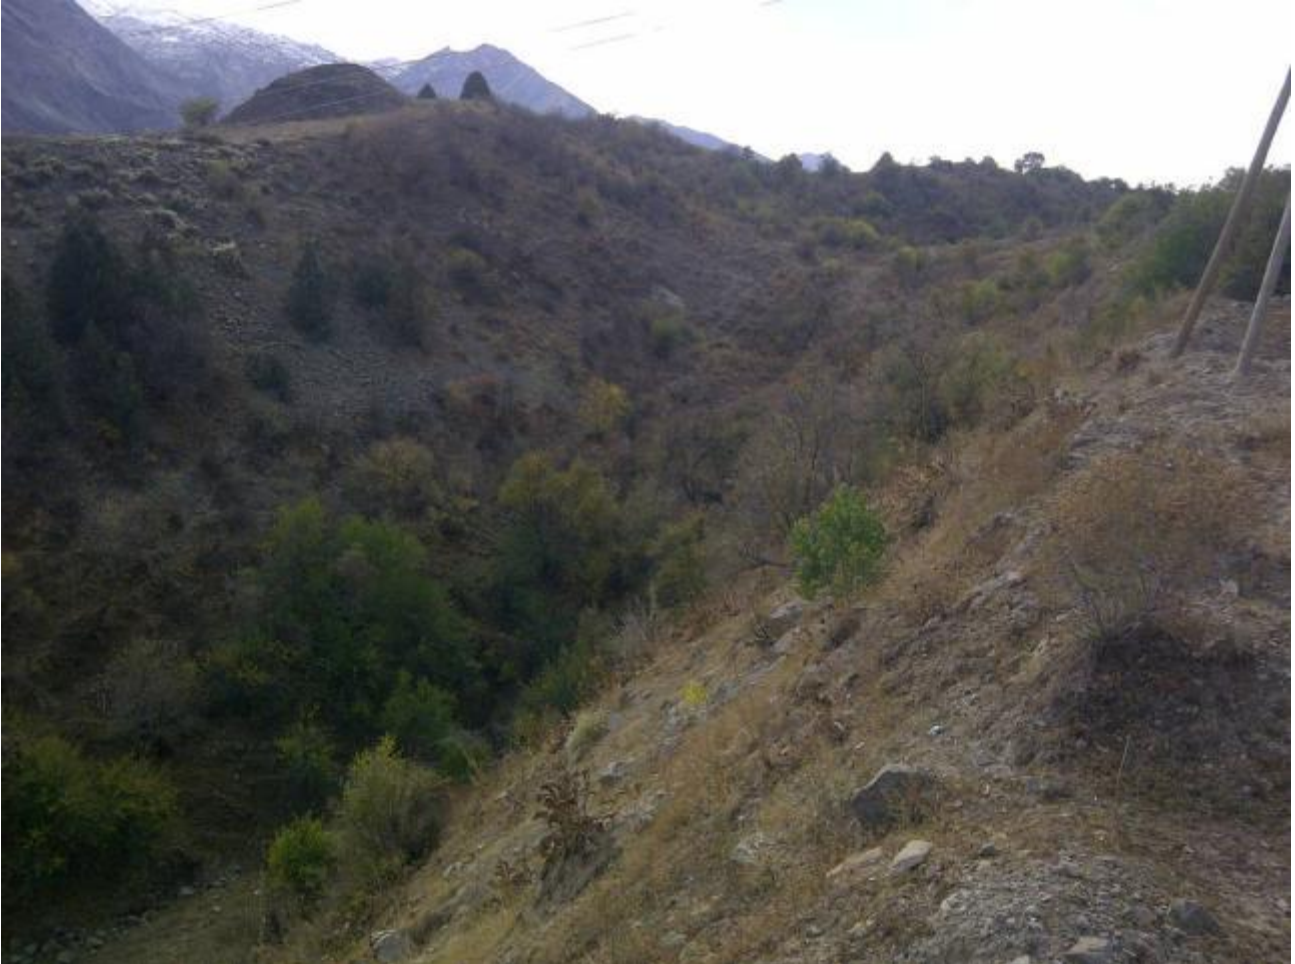
thick gypsum/clay formation in borehole DZ2, near the permanent lake sheltered in one of these depressions supports the karstic dissolution origin of observed sinkholes.

Illustration no. 38. Sinkholes elongated parallel to bedding at the eastern part of the high flat.

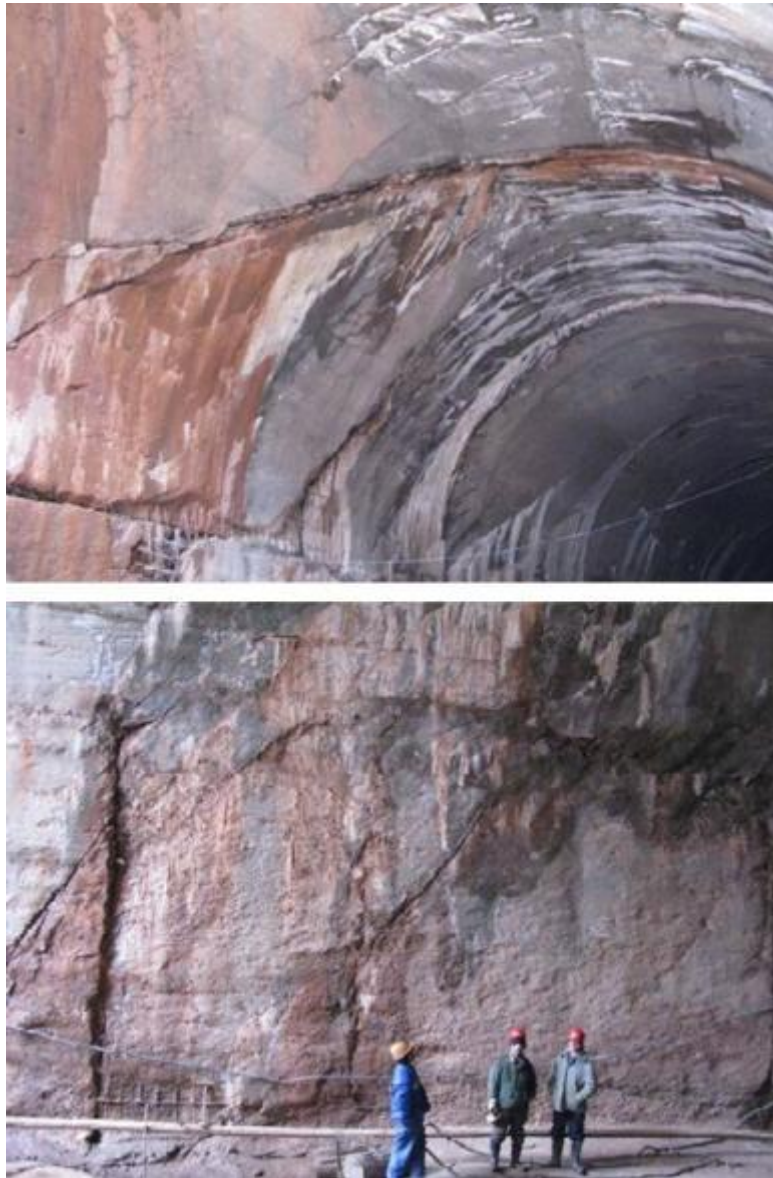
Illustration no. 44. Shearing of concrete lining and opening of construction joint in Diversion Tunnels I (above) and II (bottom).

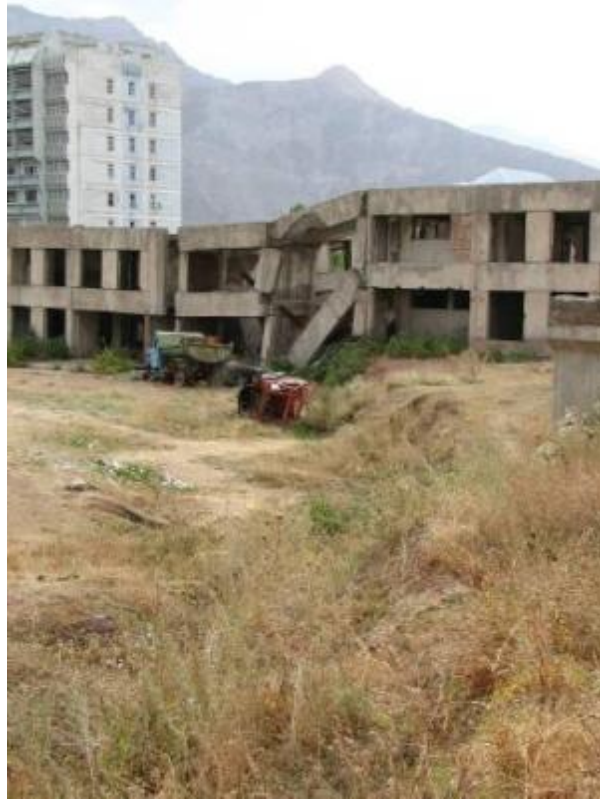
Illustration no. 45. Surface sinking causing damage to the buildings.

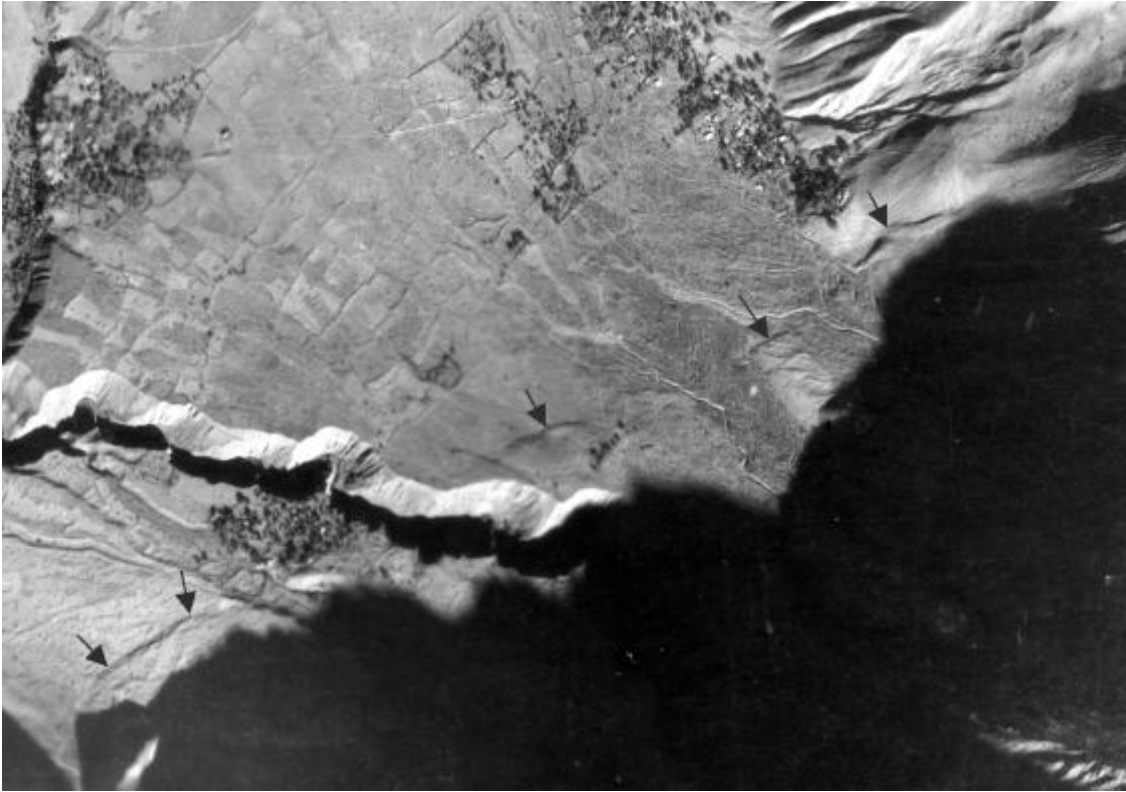
Illustration no. 46. Recent thrusts (arrows) near the foot of the Vakhsh Ridge in the area of Liabidar village.

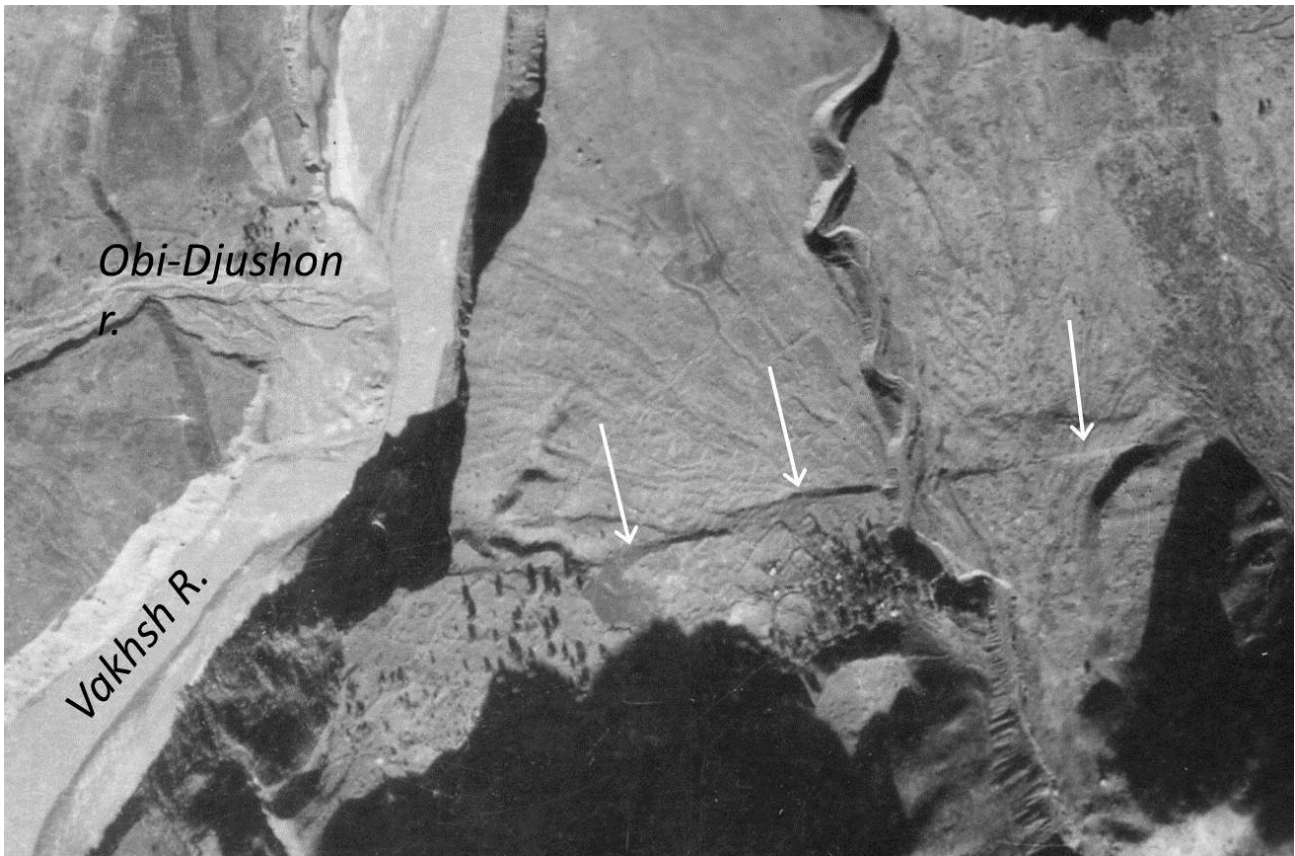
Illustration no. 48. Recent thrust rupture at the foot of the Vakhsh Ridge, crossing Tanakba gully.

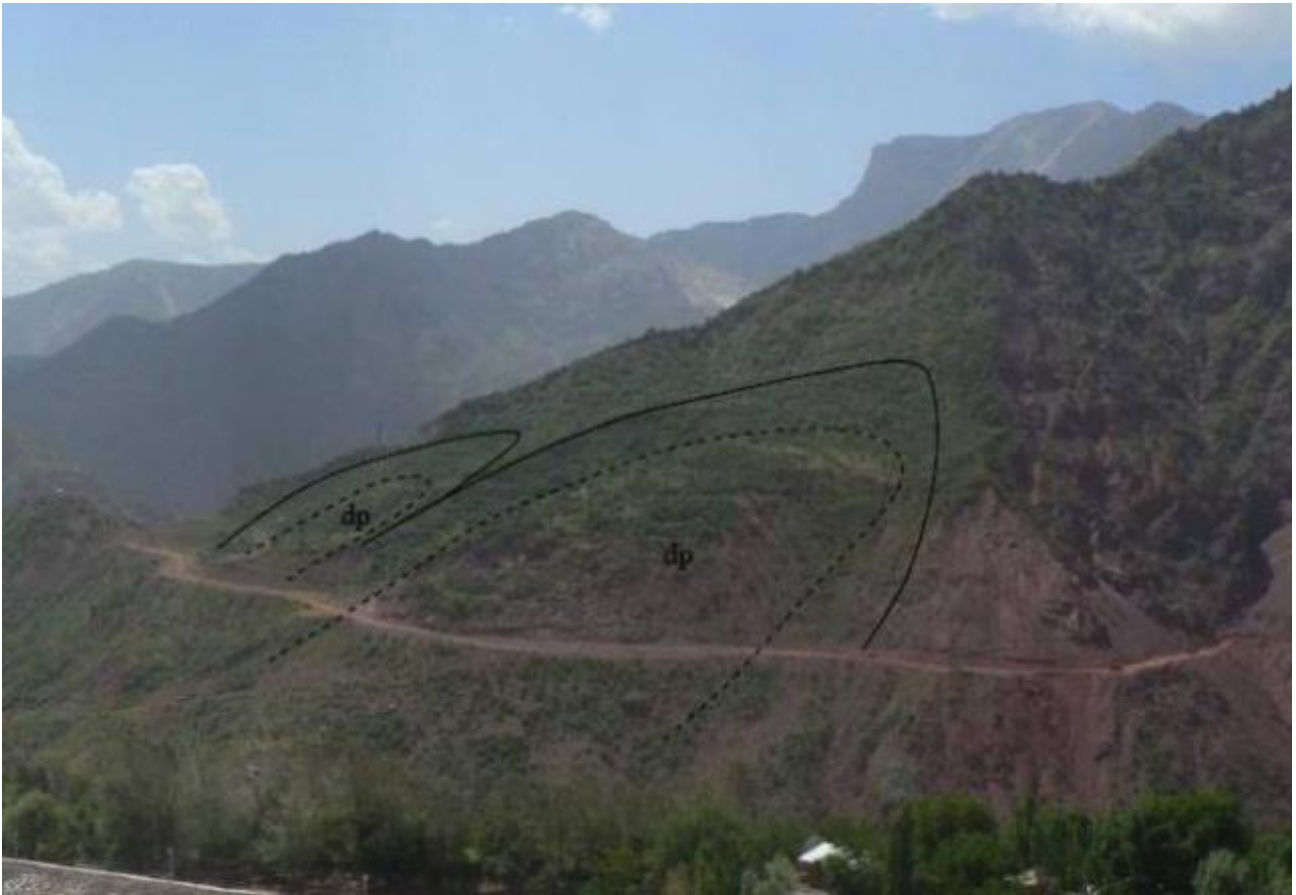
Illustration no. 49. The downstream landslide in the right bank of Passimurakho

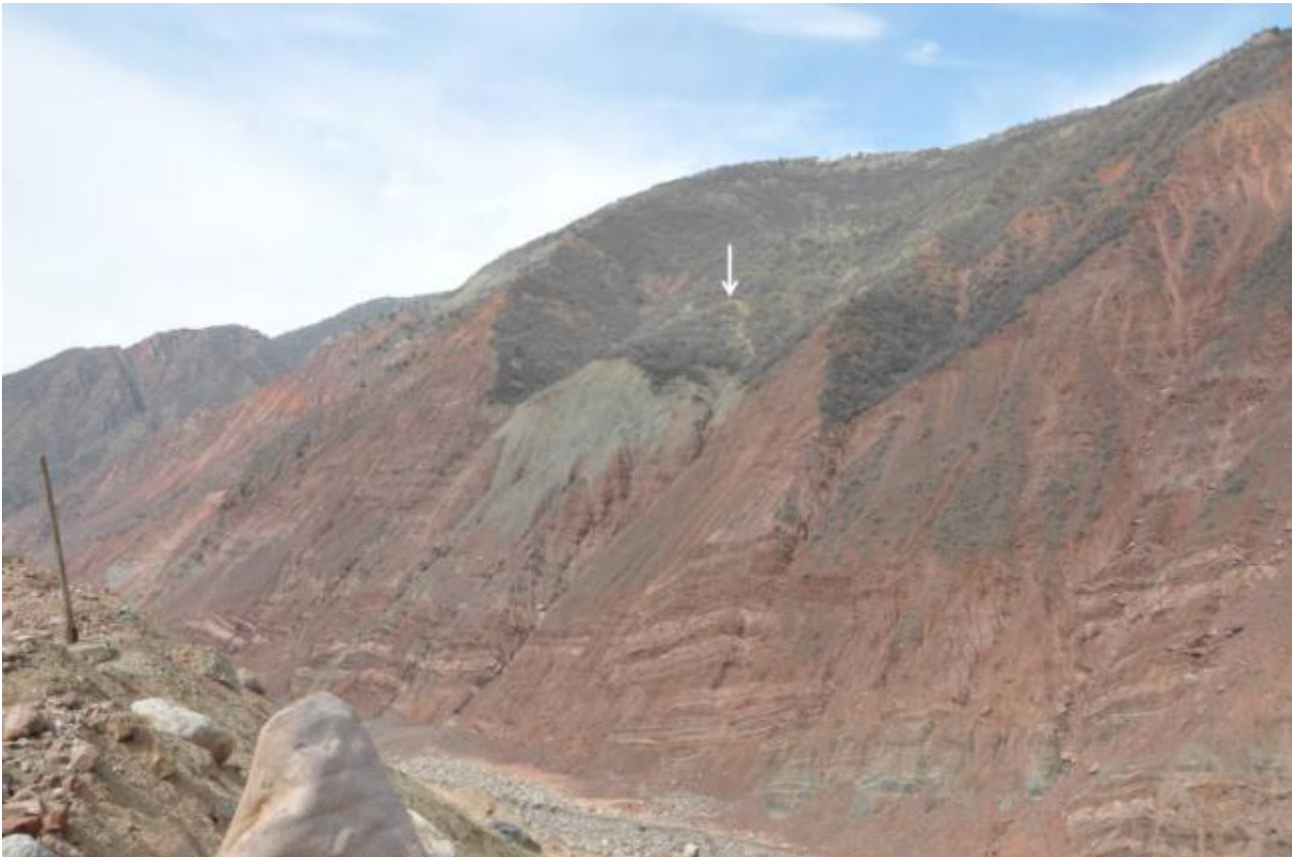
Illustration no. 50. Zone of ancient landslide in the central part of the slope. The arrow indicates the crown of recently initiated landslide.

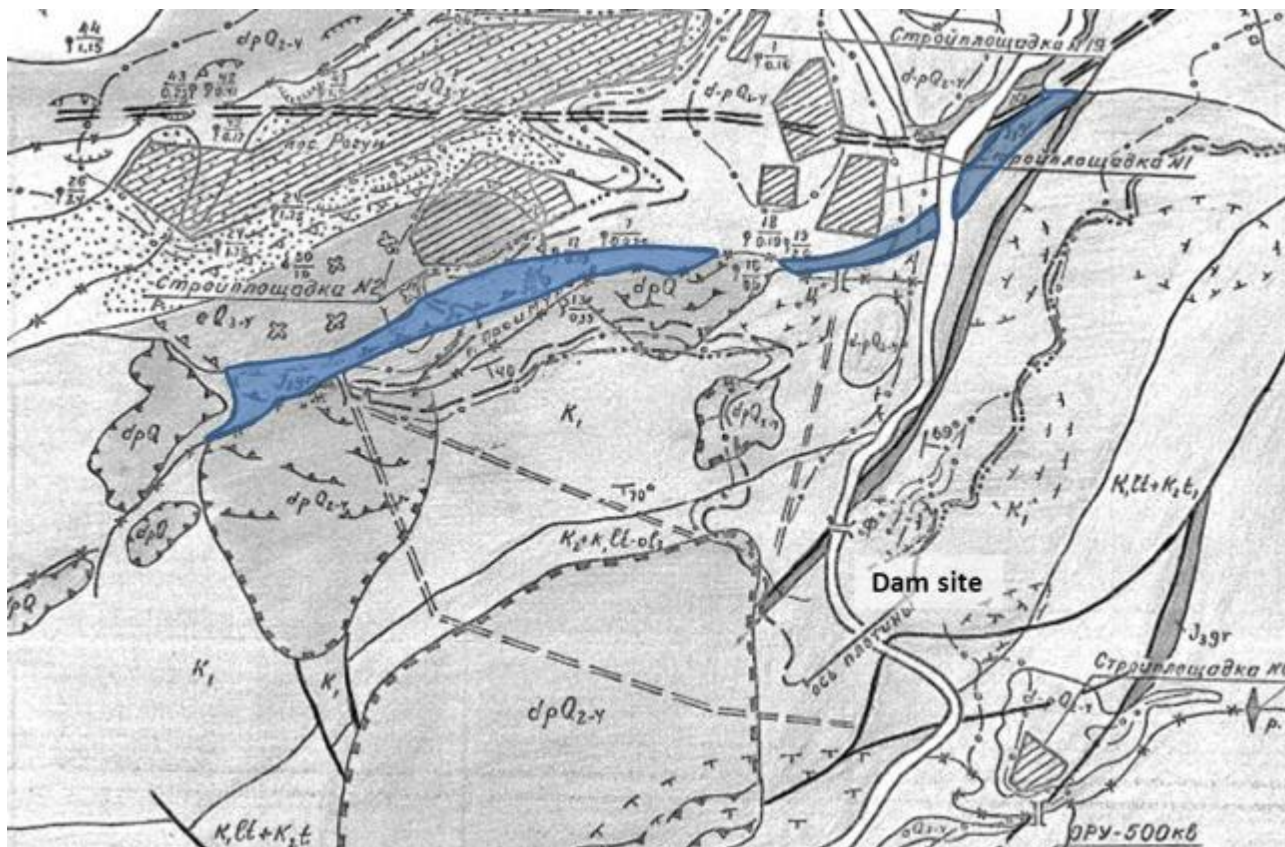
Illustration no. 52. Jurassic salt in the valley of Passimurukho.
