TECHNO-ECONOMIC ASSESSMENT STUDY FOR ROGUN HYDROELECTRIC CONSTRUCTION PROJECT

PHASE II: PROJECT DEFINITION OPTIONS

Chapter 3: Geotechnics

Report No. P.002378 RP 45 rev. C

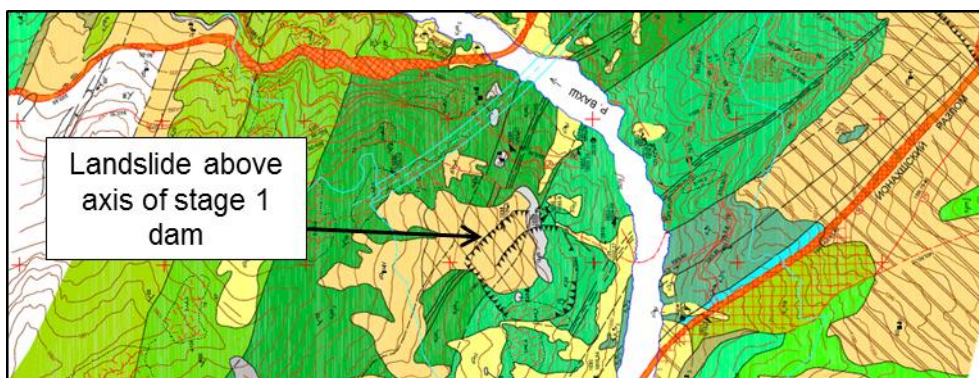
Main slope instabilities occur on the left bank, apparently potential structural instabilities along fractures of the massif with similar attitude as Fault 35, dipping towards North-West, (300-40/10-50) which are commonly continuous and infilled with clay (see Figure 2.3 and farther paragraph 6.6.1.2 and 8.3.2). Such a landslide has been identified just above the axis of the stage 1 dam, in the shoulder zone of the main dam, between elevation 1060 and 1180, more or less between the dam core and Ionakhsh Fault, with an approximate width of about 130 m and extending along the slope for about 160 m. (Ref.[24], 2.3.3.2.1.). Location of this landslide is shown on Figure 2.4.

Figure 2.4: Identification of the landslide on the left bank

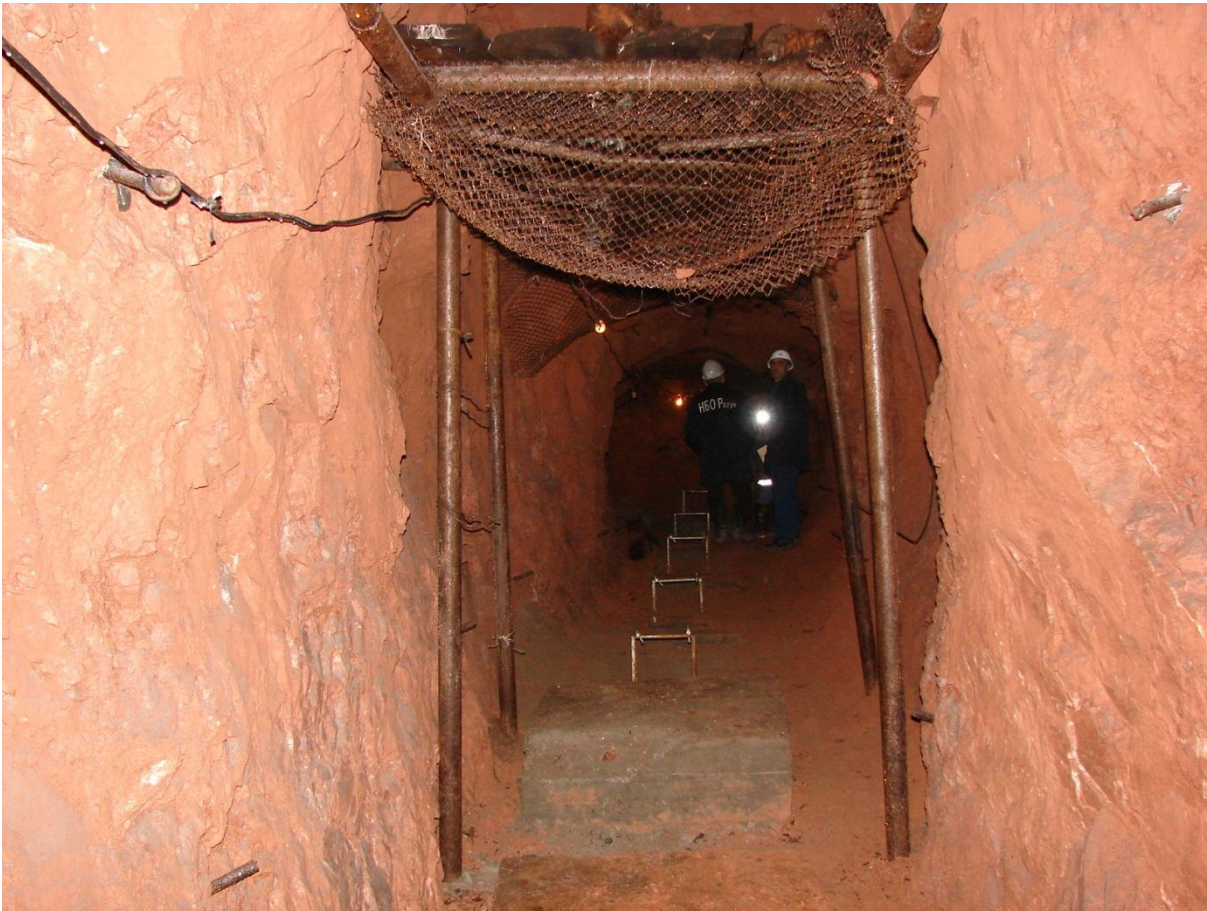
No infiltration of water was noticed within the claystone, but observations made outside reveal that these claystones should most likely lose of their mechanical characteristics if distressed and submitted to weathering.

Figure 8.2: View of instrumentation adit excavated just south of the Ionakhsh Fault, from gallery 1034, within Gaurdak claystone

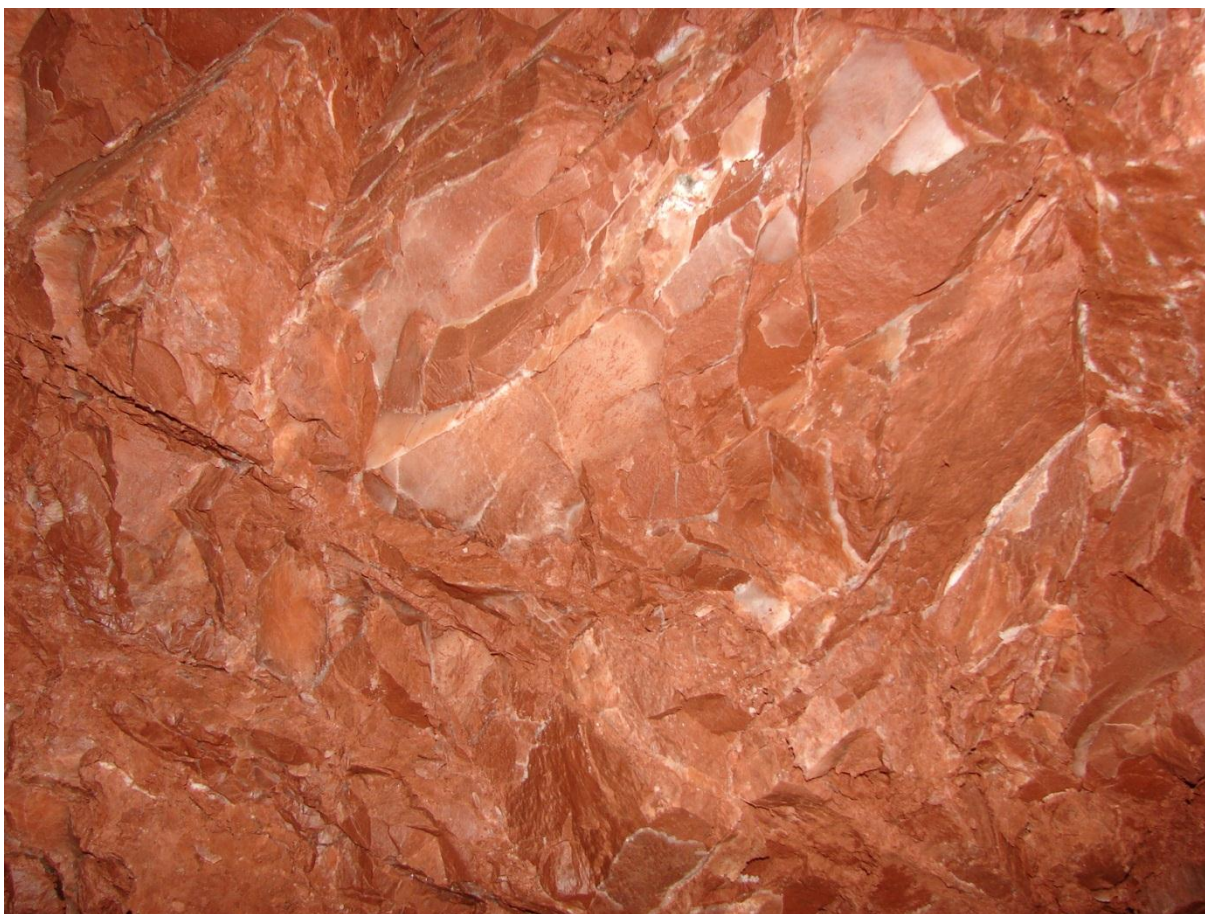
Figure 8.3: Close view of Gaurdak claystone and quasi-systematic, fine gypsum encrusting of discontinuities (gallery 1034)

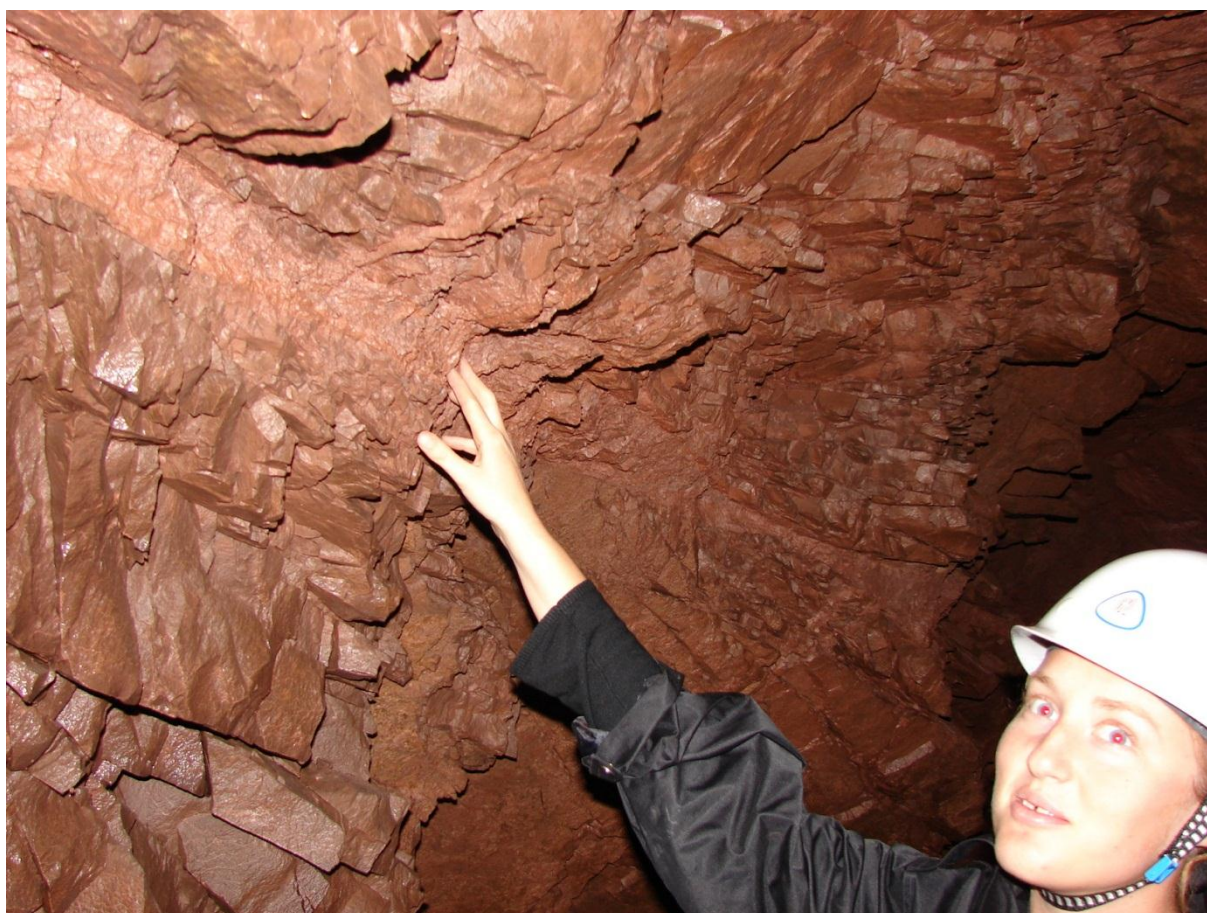
When visiting the gallery 1030 in April 2012, water was dripping in many places from the joints, depositing fine layers of clayey material on the walls of the fractures. Even considering that we were in snow-melting period, which would mean that actual permeability is medium, and may be rather high in the direction of the bedding joints. Based on these observations, the assumption of a global permeability of 0.2 LU (some 2×10^{-8} m/sec) seems to be underestimated. From observation, a value of some 10^{-6} m/sec appears more adequate.

Figure 8.4: Kyzyltash Formation in investigation gallery 1030; one will note the subhorizontal joint with clay infilling and general dampness of the rock

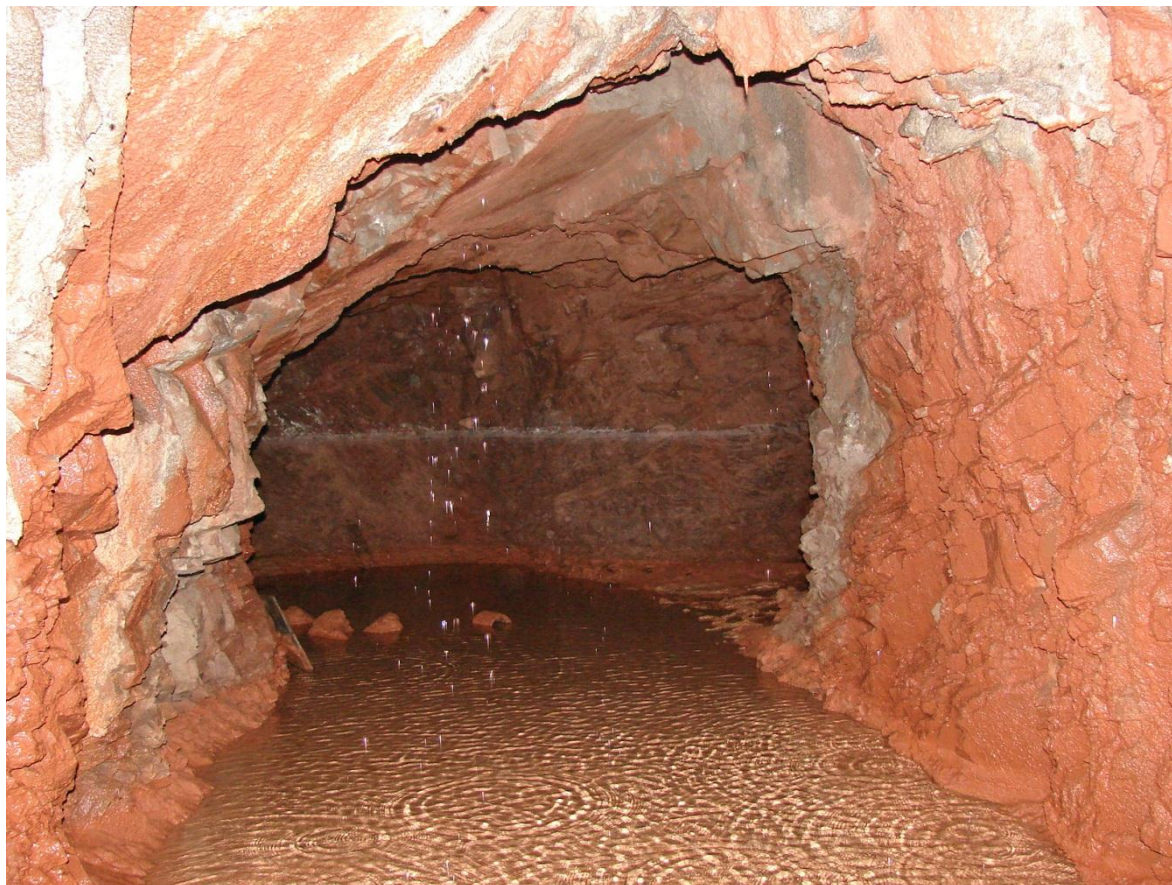
Figure 8.5: View of water circulations within a branch of investigation gallery 1002; red clay is clearly seen being taken along by water along the joints, then depositing on the floor

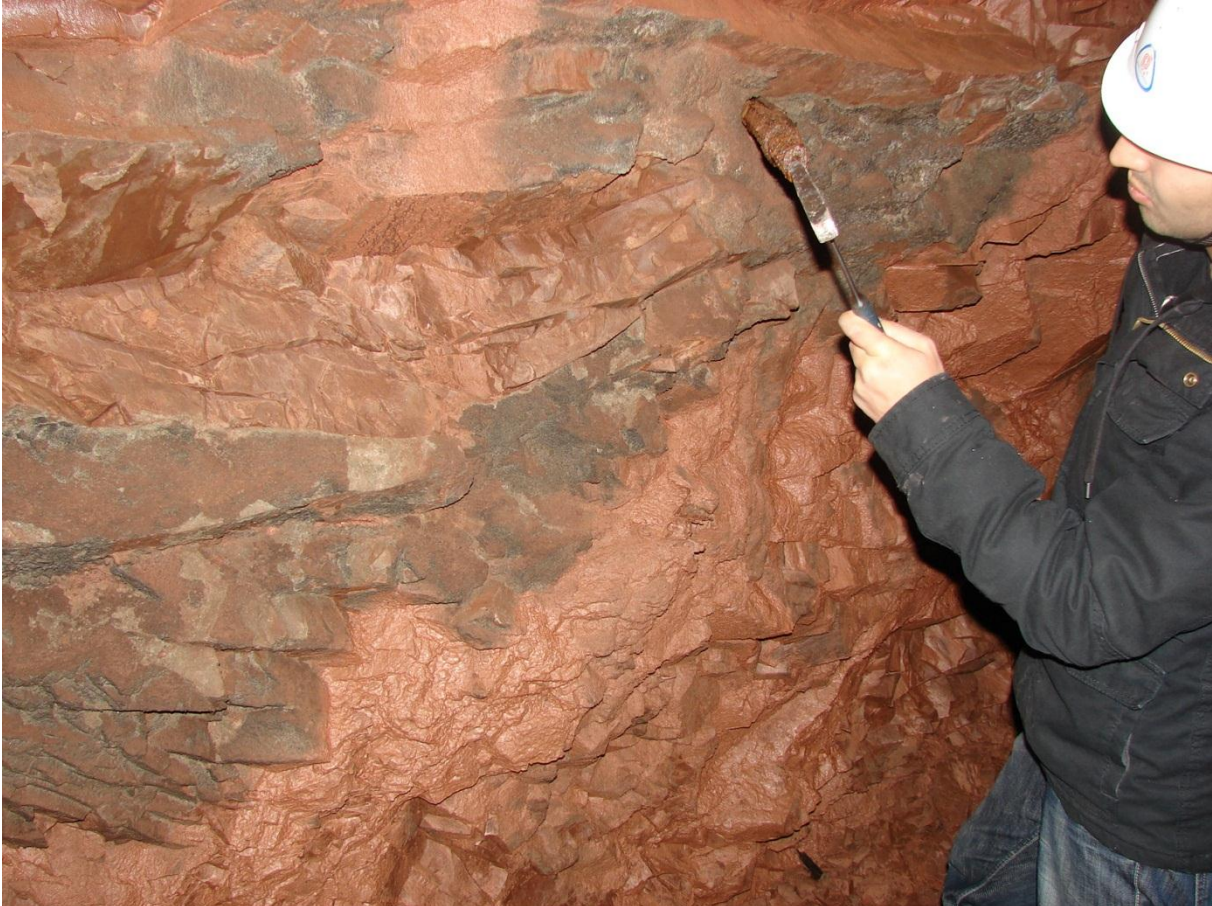
The rapid alteration of the siltstones when distressed and exposed has been emphasized in paragraph 6.5.2 and 7.4.2.2, and the gallery had effectively to be supported with wood structures in some places, dampened with water. In such conditions, the siltstones apparently lose part of their mechanical characteristics. However, from the observations, the siltstones where stressed and confined seem not to be too much affected by this weathering.

Figure 8.6: Lower Obigarm siltstones in gallery 1002

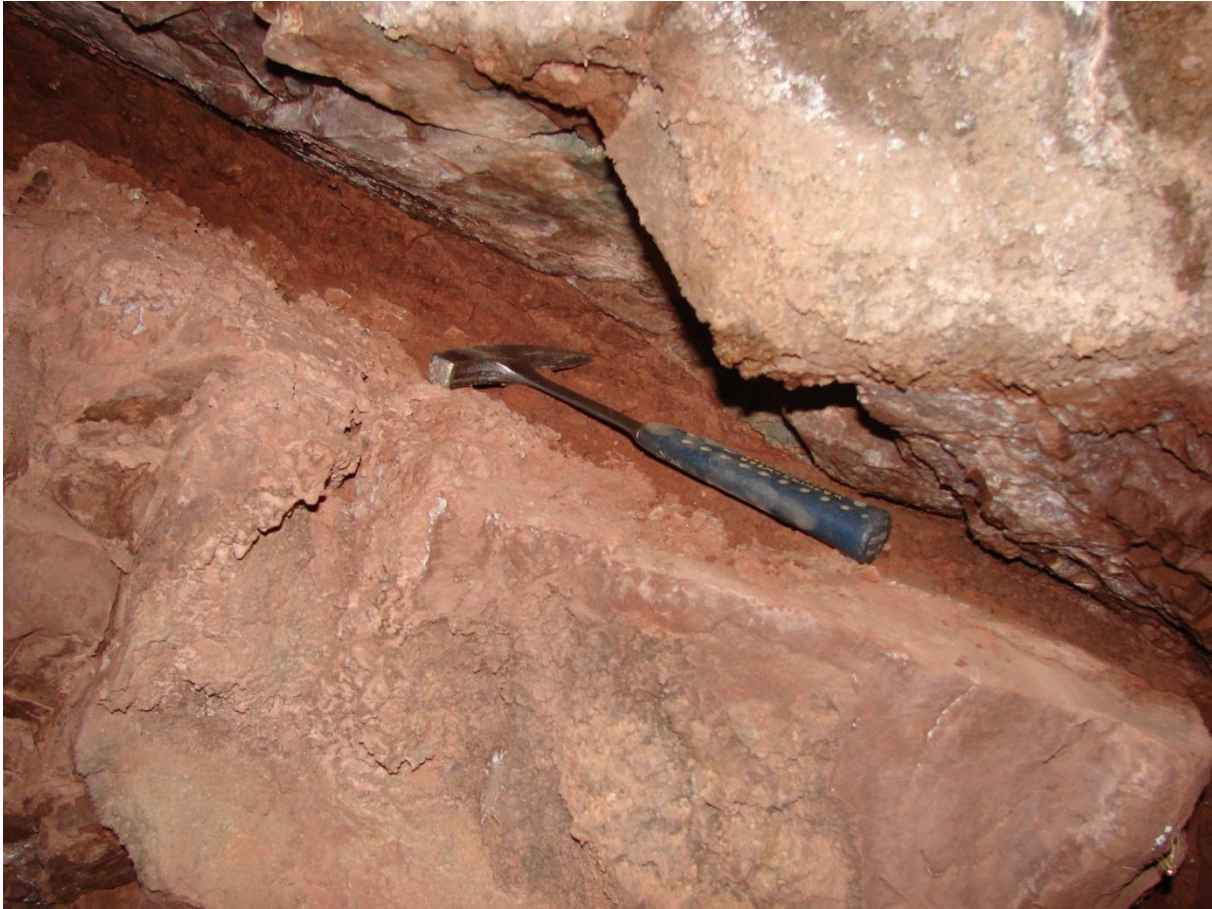
This fits with the observation made in outcrops, and also in the investigation galleries inspected, where several faults and discontinuities of various dip angle (from sub-horizontal to 45 degrees) were encountered, with dip azimuth similar as Fault 35 and joint set No.4. One of the common features of these discontinuities is that, where very persistent and planar, they intersect all rock formations and are often infilled with plastic clay (up to several centimetres thickness). These observations were already reported in the Original Design Report (see paragraph 6.6.1.2). A typical example of such joints, here rather a fault, is showed in Figure 8.7.

Figure 8.7: Fault similar in dip azimuth as Fault 35, with some 50 mm infilling of pure plastic clay (investigation gallery 1002, downstream of Fault 35)

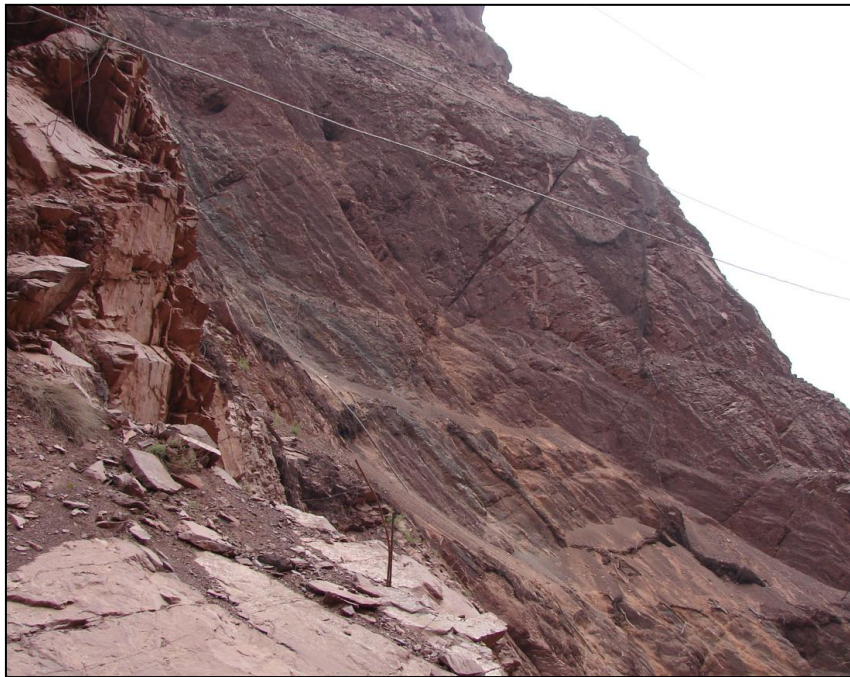
Figure 8.8 shows one of these main discontinuities (probably Fault 32, as per original drawing 1174-03-78, Sheet 1 of Ref.[1]) cutting both the Lower Obigarm siltstones of the dam core foundation and the Upper Obigarm sandstones.

Figure 8.8: Fault of similar attitude as Fault 35, dipping towards upstream, cutting the Lower Obigarm siltstone and Upper Obigarm sandstone; in the background; other joints pertaining to the same system are clearly visible (bedding attitude steeply dipping towards upstream)

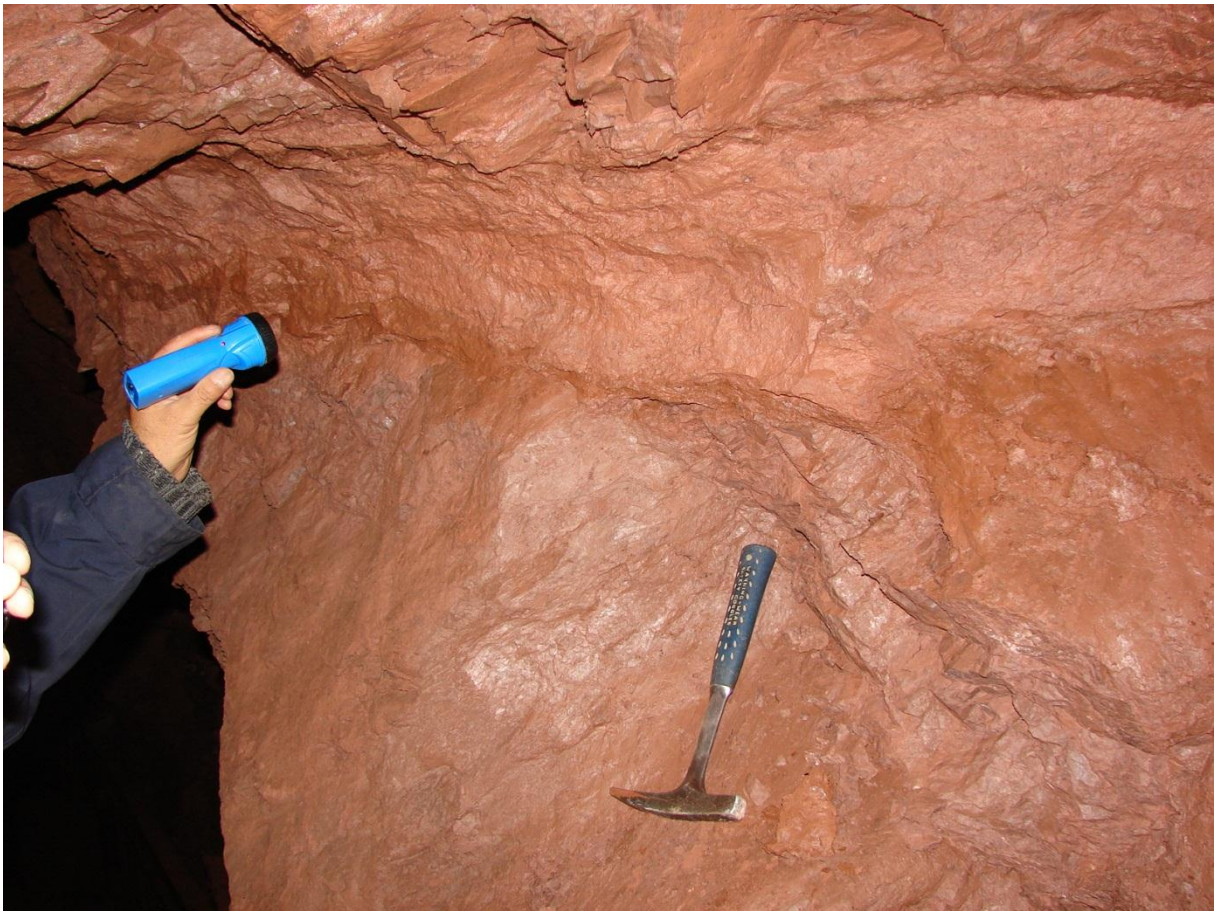
This fact, combined with the collapse occurred in the diversion tunnels where crossing Fault 35, demonstrates that adverse geological conditions are to be forecasted there, and over the whole tectonic lens between the branches of the fault. Figure 8.9 shows the jointing and overall presence of clay in this area (on the photograph, just upstream the northern branch of the Fault).

Figure 8.9: View of the rock just upstream the northern branch of Fault 35; fine clay is present along most of the joints (gallery 1002)

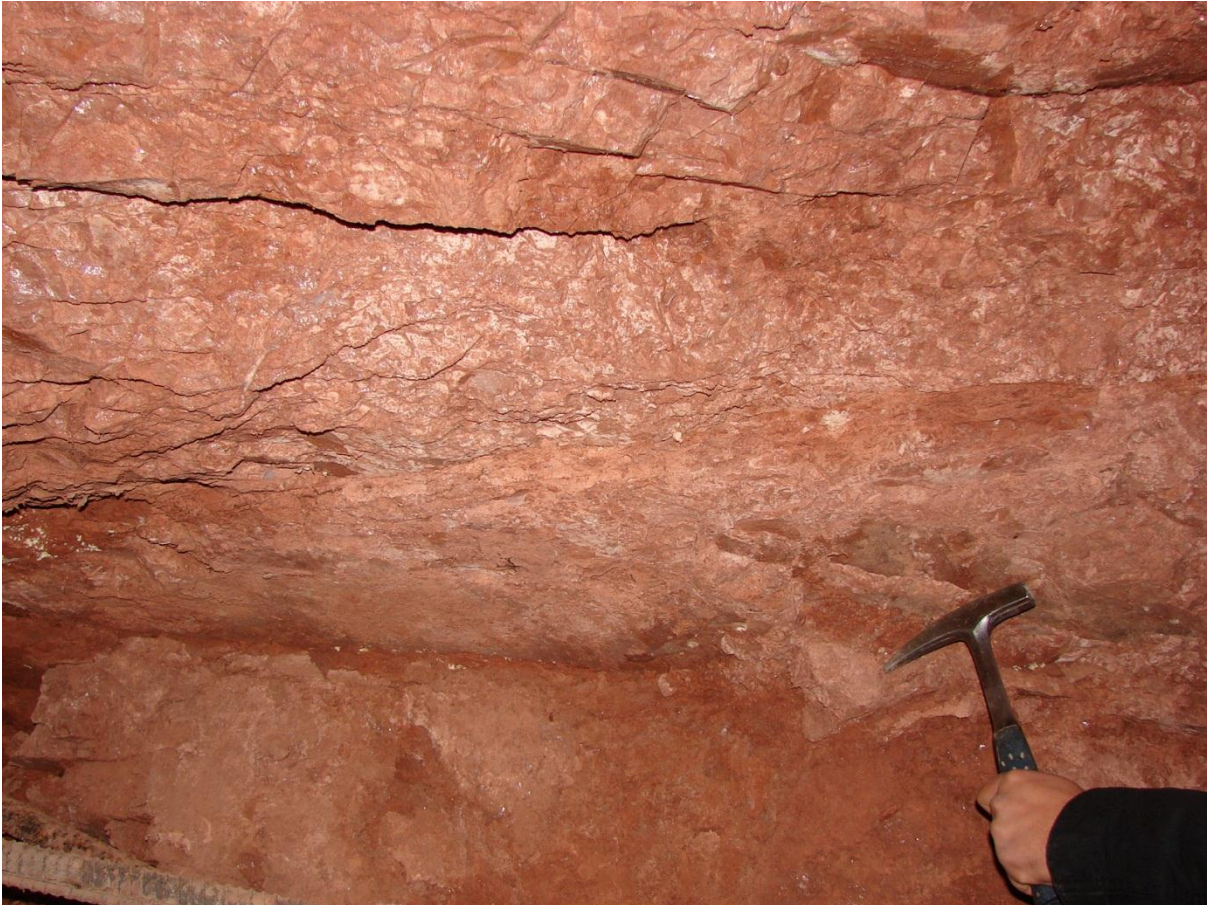
No salt rock is visible there, since elevation of the top of the wedge is below the river level.

Figure 8.10: Breccia of Ionakhsh Fault, in gallery 1001, right bank

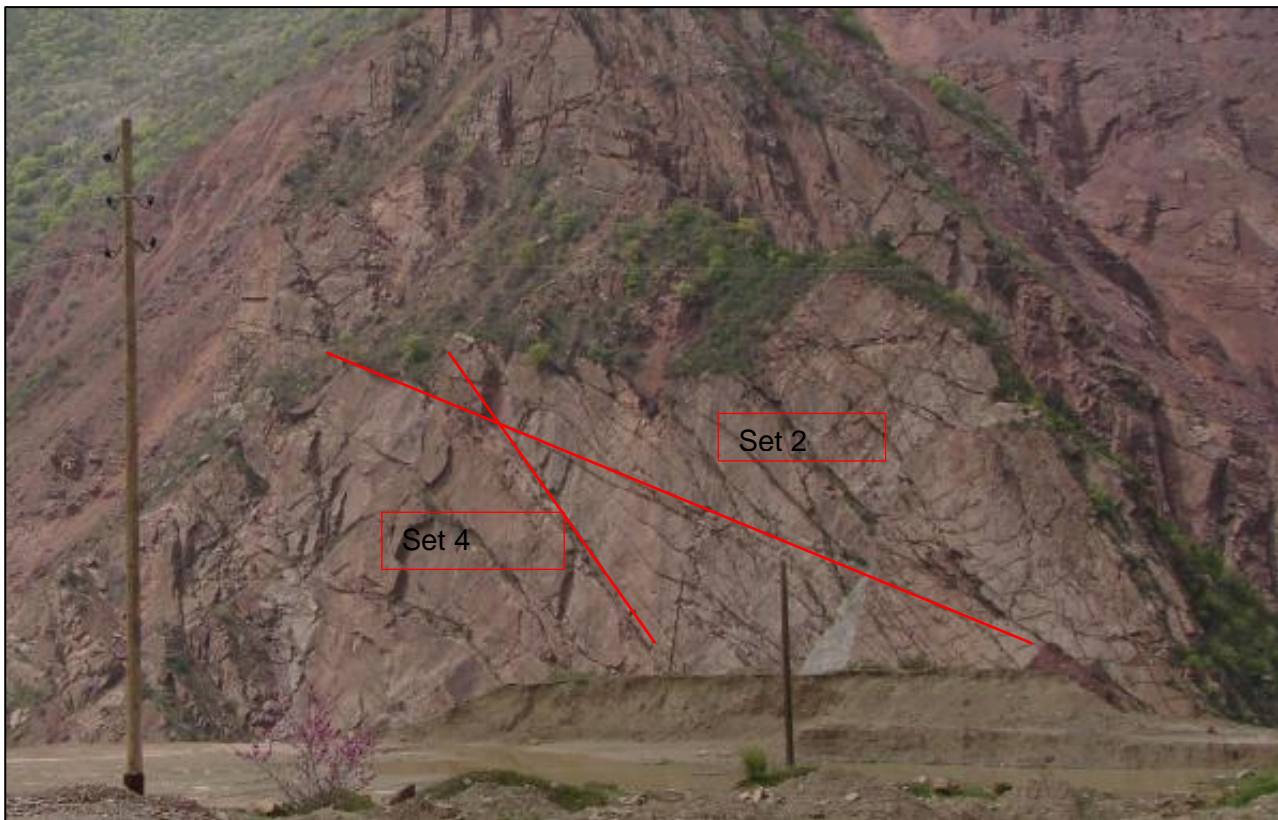
Figure 10.1: Photograph of the rock spur of downstream right bank, showing joint sets 2 and 4

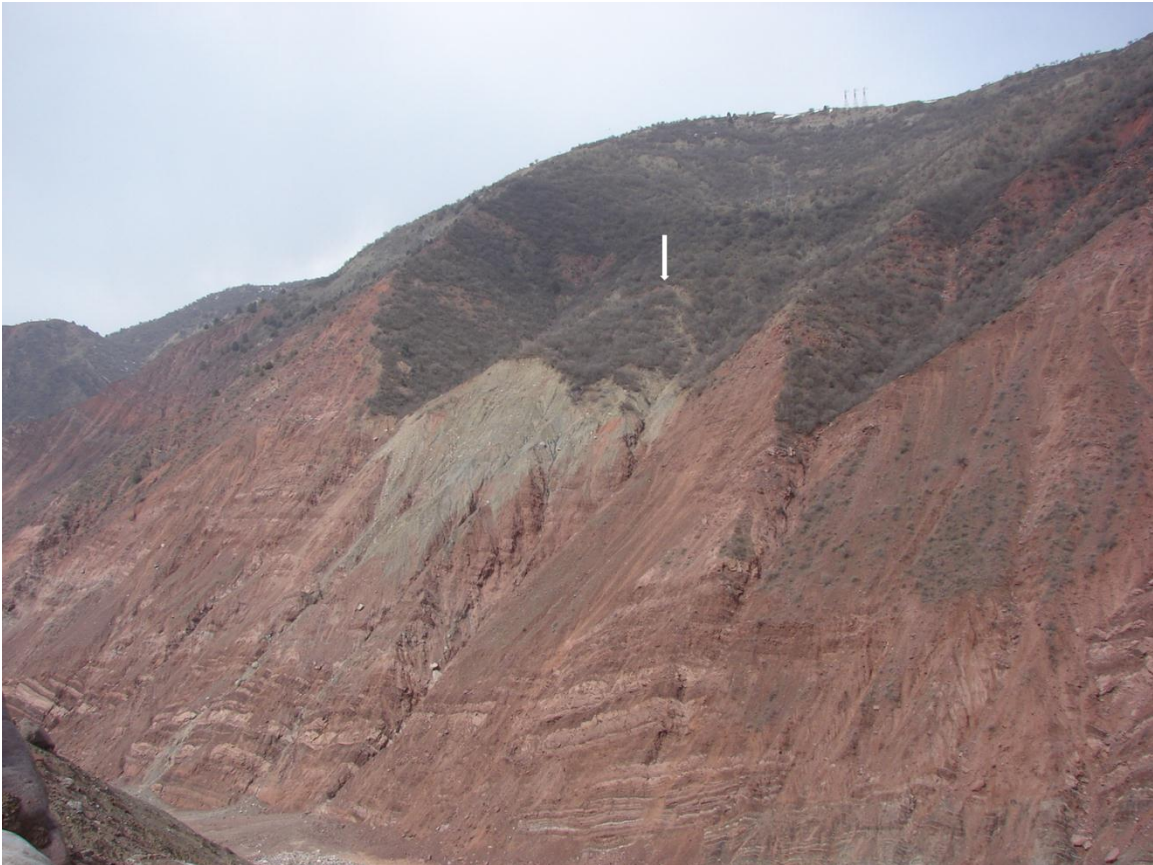
Figure 12.3: Right bank slope of the Vakhsh River, just downstream of the dam site, in the disturbed zone; the white arrow indicates the head scarp of an apparently active landslide

Figure 12.4: Illustrative sketch of remedial measures for treatment of potential landslide of the front slope of the disturbed zone

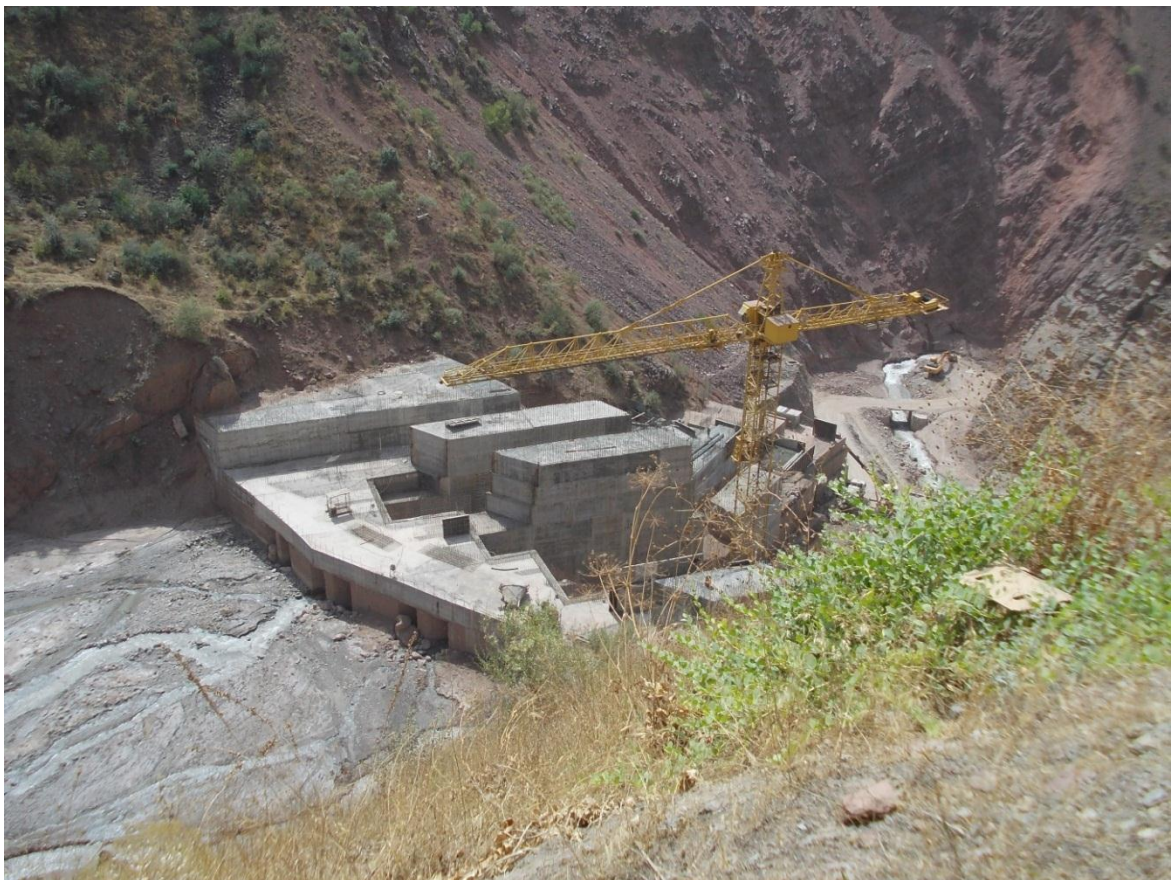
Figure 12.7: Obi-Shur retention dam in August 2012; mudflows already almost backfilled the river behind the completed part of the dam
