# TECHNO-ECONOMIC ASSESSMENT STUDY FOR ROGUN HYDROELECTRIC CONSTRUCTION PROJECT

## PHASE II: PROJECT DEFINITION OPTIONS

#### Chapter 2: Geology

#### Part B - Geological Investigation in the Right Bank

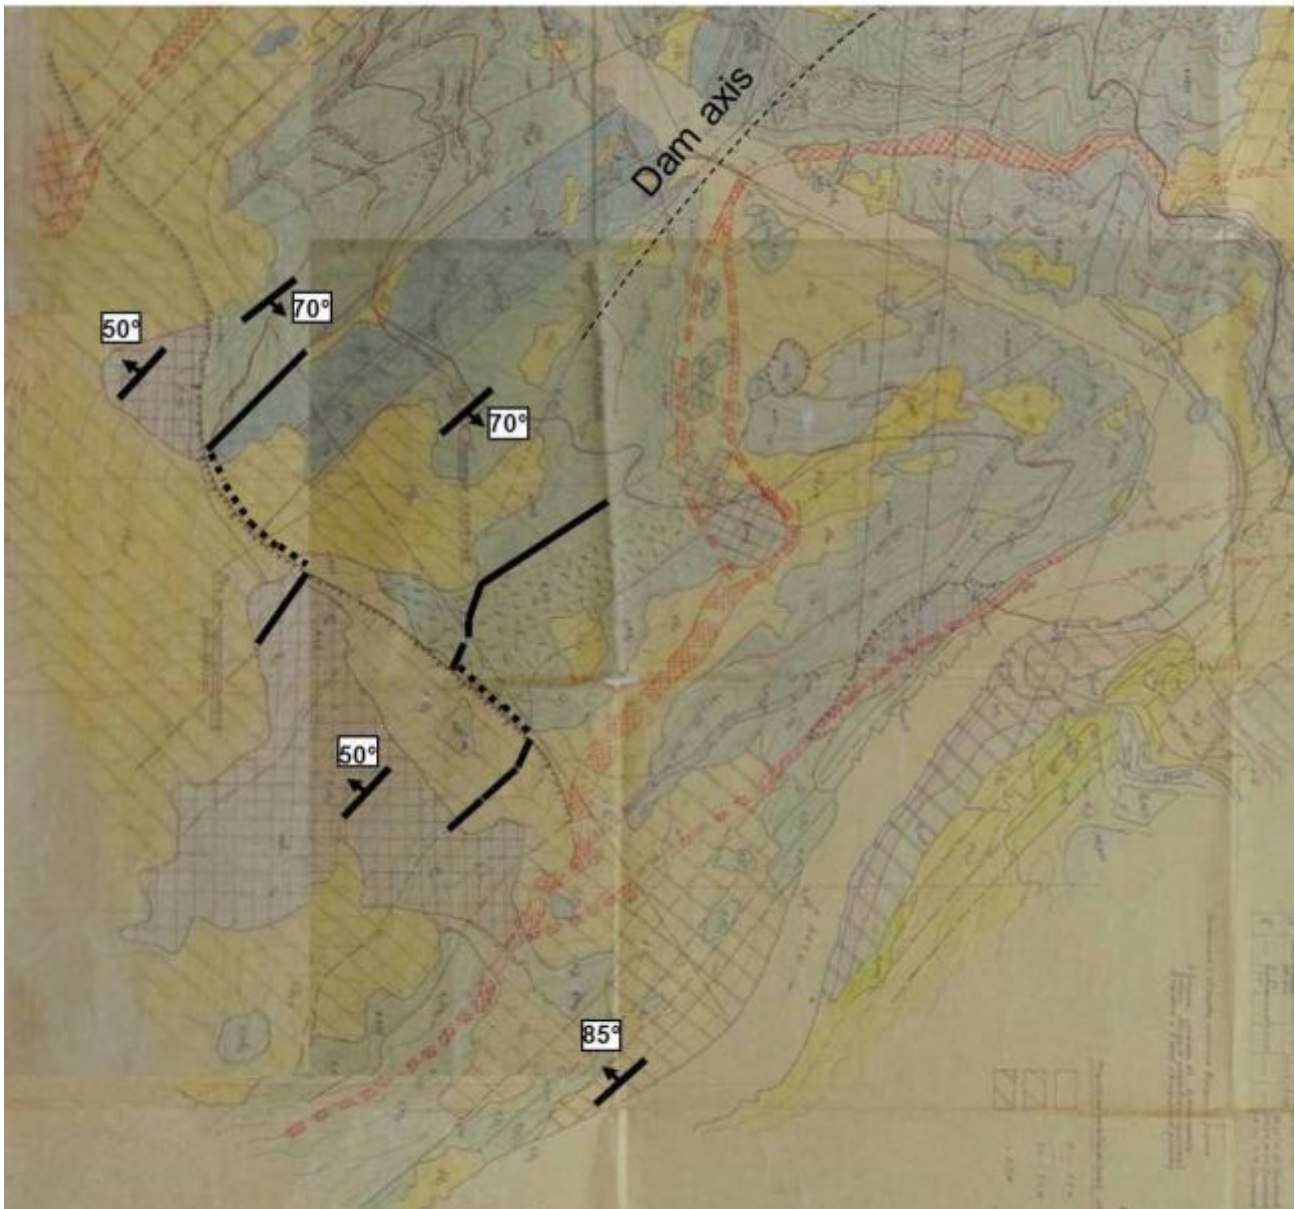
Illustration no.3. Extract of the 1978 geological map. Enhanced geological contacts and bedding structural positions highlight the inferred offset and the sharp change of bedding dip.

As represented on the geological map, of which an extract is presented in Illustration no.3, the downslope offset was interpreted as the result of tear-off along the eastern boundary of the 'landslide zone'.

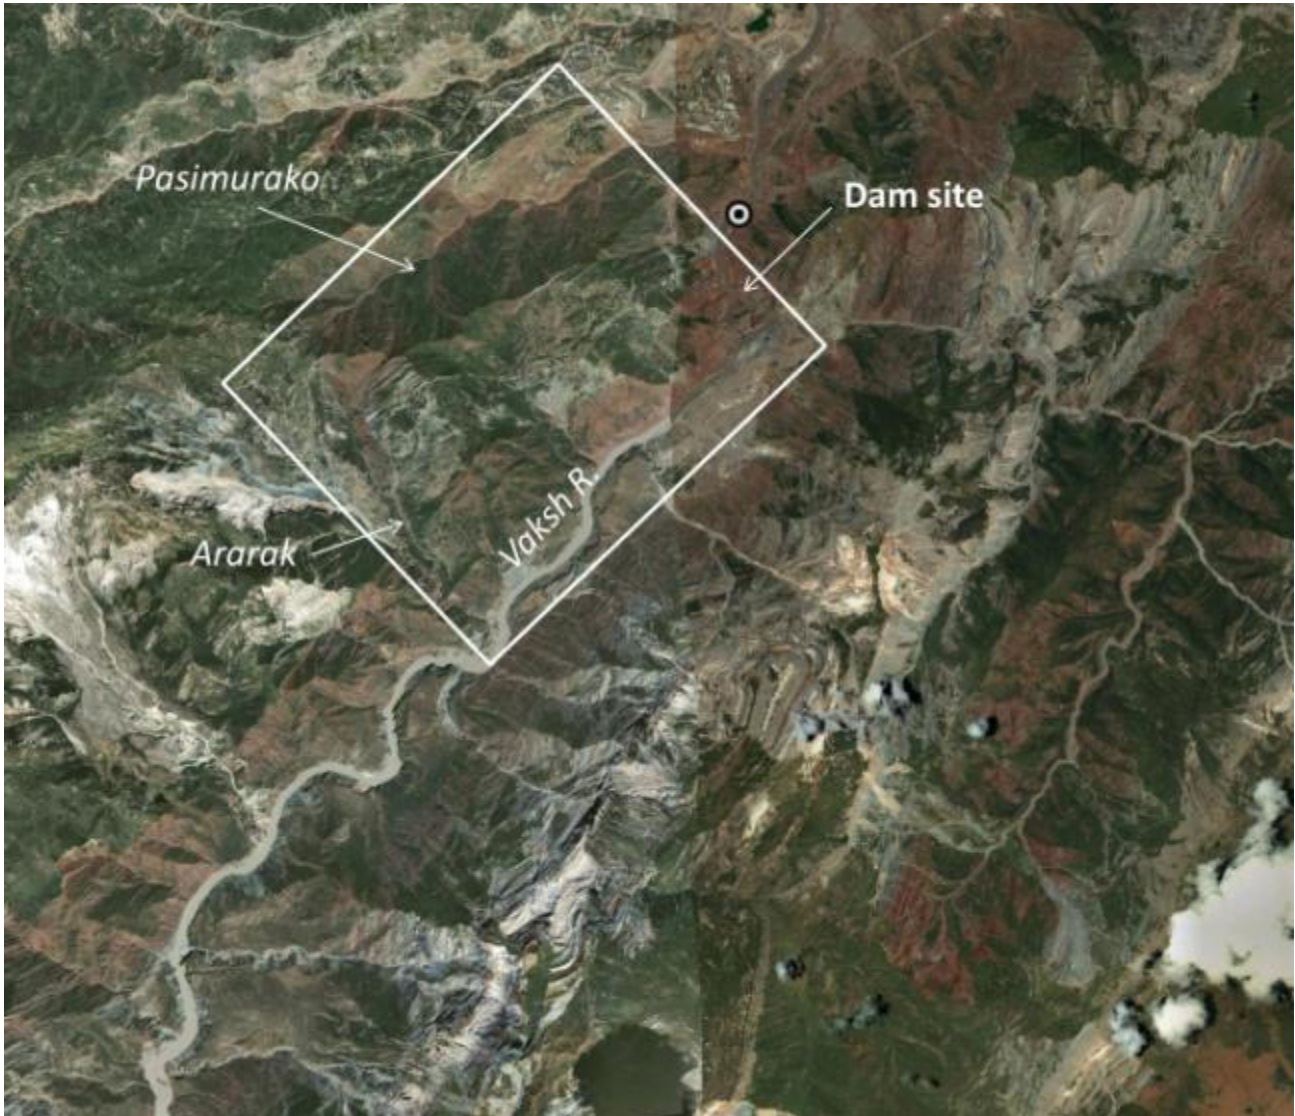
Illustration no.7. The white frame indicates the area of interest in the right bank.

The area of interest is indicated in Illustration no.7. This block has clear geomorphological boundaries. It can be considered as the natural extension of the Right Bank of the dam site, for instance for the purpose of hydrogeological modeling.

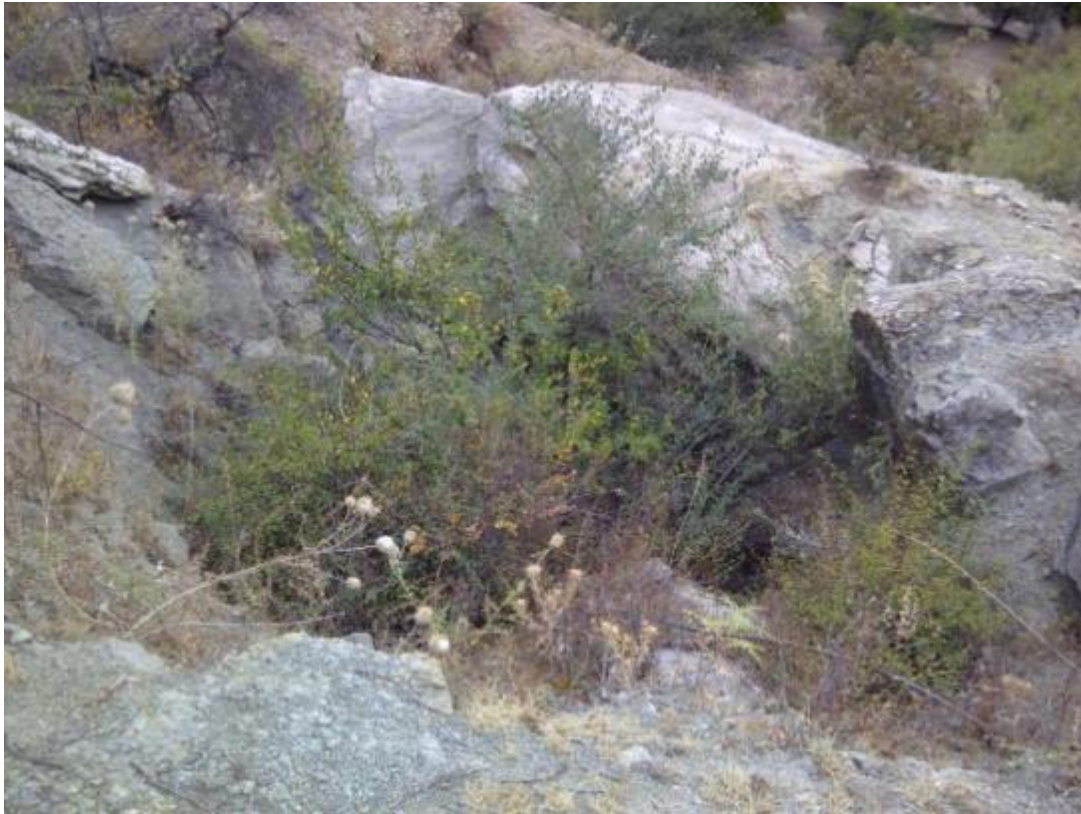
Illustration no.8. Sinkhole in thick gypsum layer, left bank of Ararak stream.

In the Ararak stream, the Upper Cretaceous formations of Santonian, Coniacian, and Campanian-Maastrichtian were identified. Among them, the Santonian formation includes thick gypsum layers which exhibit numerous karst dissolution features (Illustration no.8).

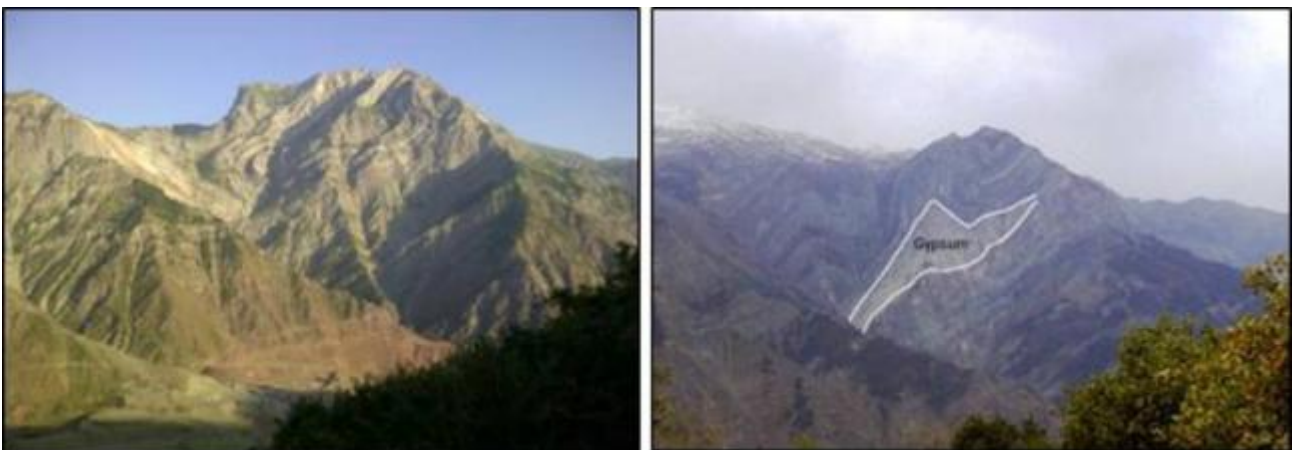
Illustration no.9. Salt tectonics, bubble wrap folds in the left bank opposite to the atypical area.

Such gypsum is apparently responsible for the outstanding bubble wrap folds, typical of salt/evaporite tectonics, which are visible in the opposite bank of the Vaksh River (Illustration no.9). It is concluded that in the area of the project, the tectonic stresses are accommodated by décollement not only in the Jurassic salt formation but also at other favorable levels above it.

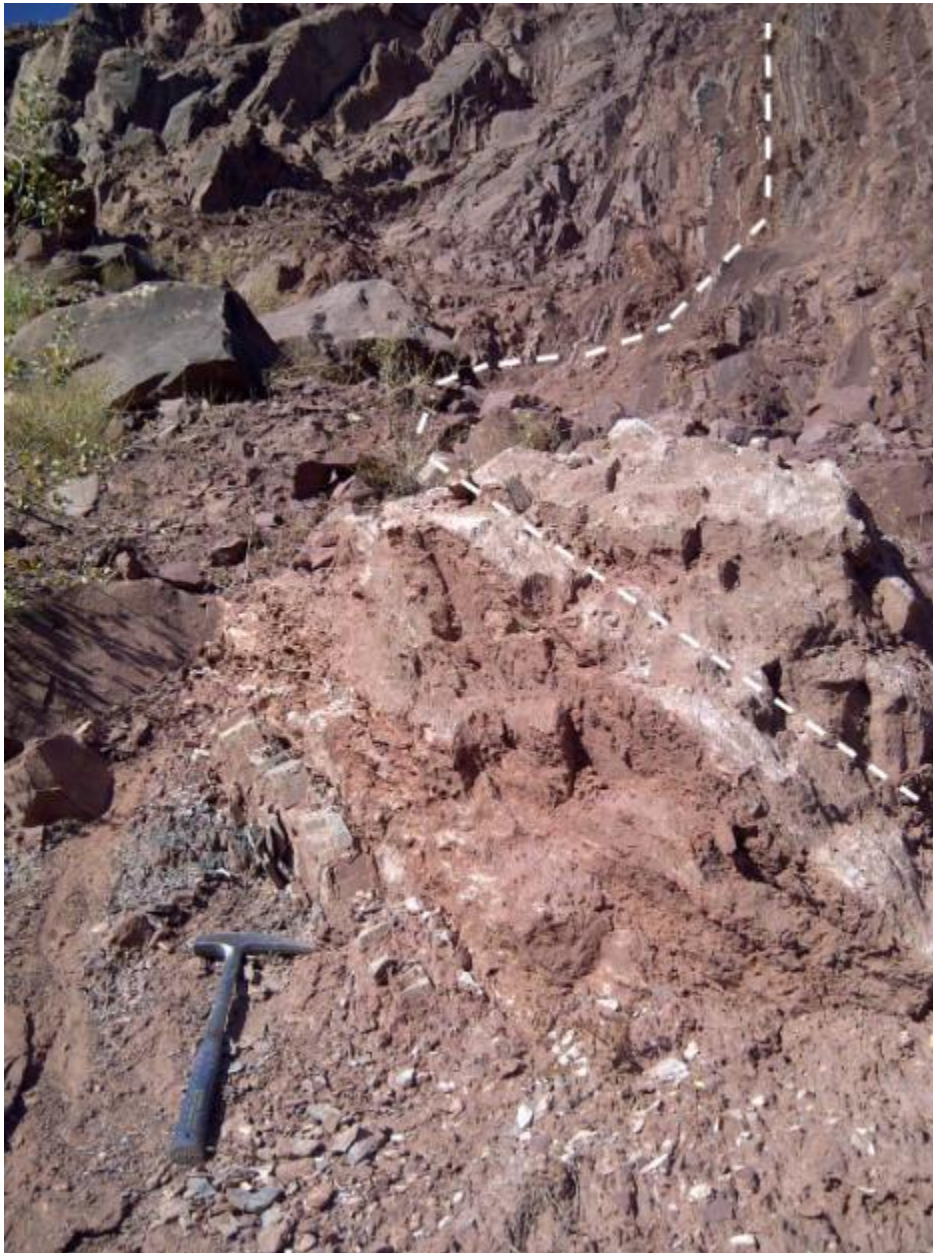
Illustration no.12. Near the eastern boundary of the atypical zone. The structural position of this gypsum layer and adjacent shales, almost perpendicular to that in the undisturbed area, indicates bending instead of lateral offset across discontinuity.

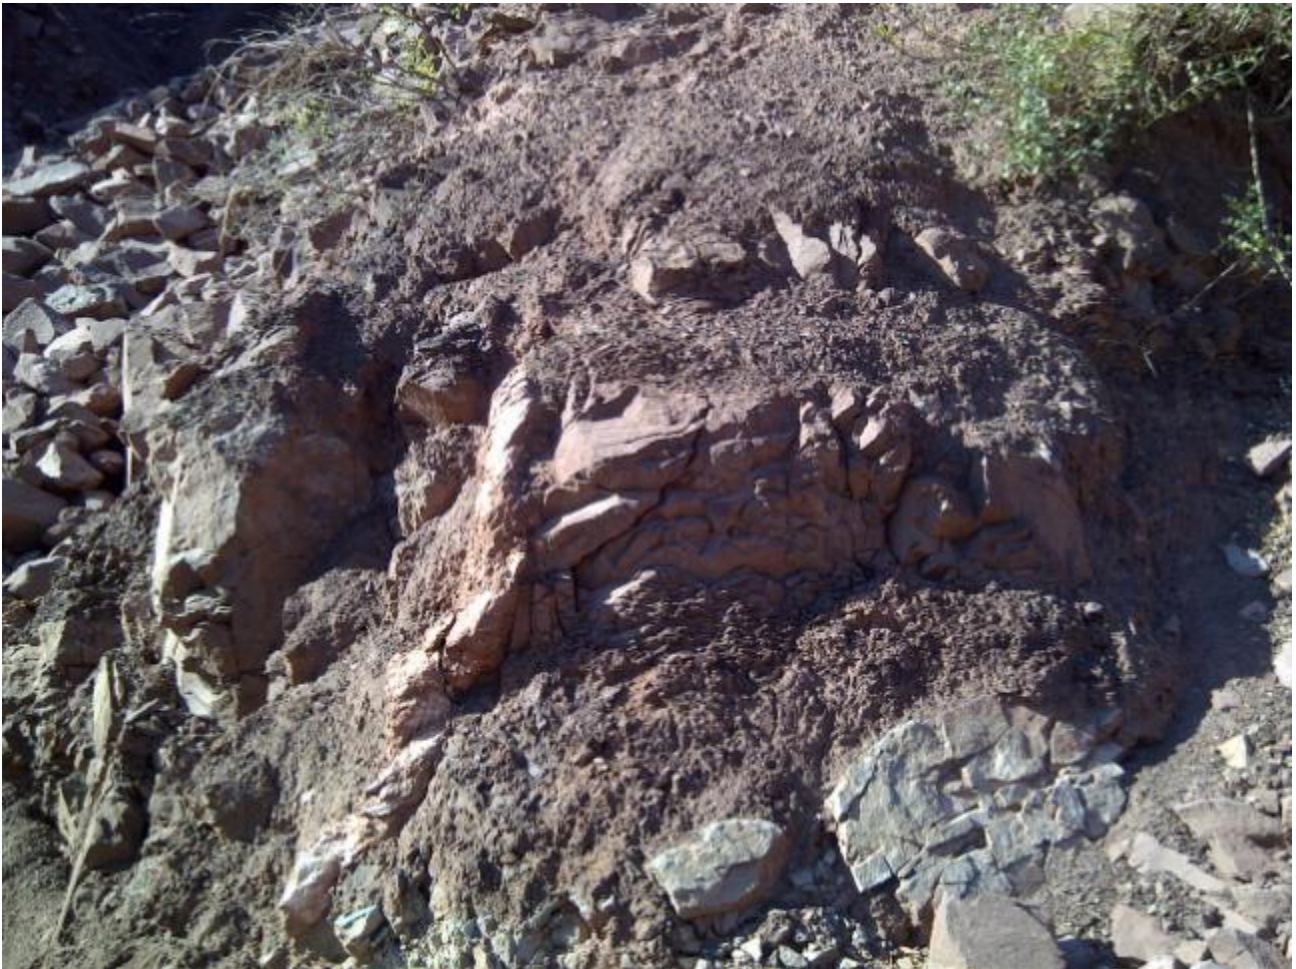
Illustration no.13. On the steep slope of the atypical zone, in overturned Lower Cretaceous sequence. Brittle deformation of sandstone, next to ductile deformation of gypsum and mudstone. Remobilization of gypsum within the fracture which cross-cuts the bedding in sandstone layers is consistent with slow, tectonic driven deformation of this rock-mass.

In the area of the assumed Eastern boundary of the 'landslide zone', no evidence of NW-SE tear-off zone has been found. On the contrary, field observations rather suggest that the apparent senestral offset of the layers results from ductile deformation (bending) as opposed to sharp shearing (Illustration no.12). Other observations on the slope are also indicative of slow tectonic deformation (Illustration no.13).

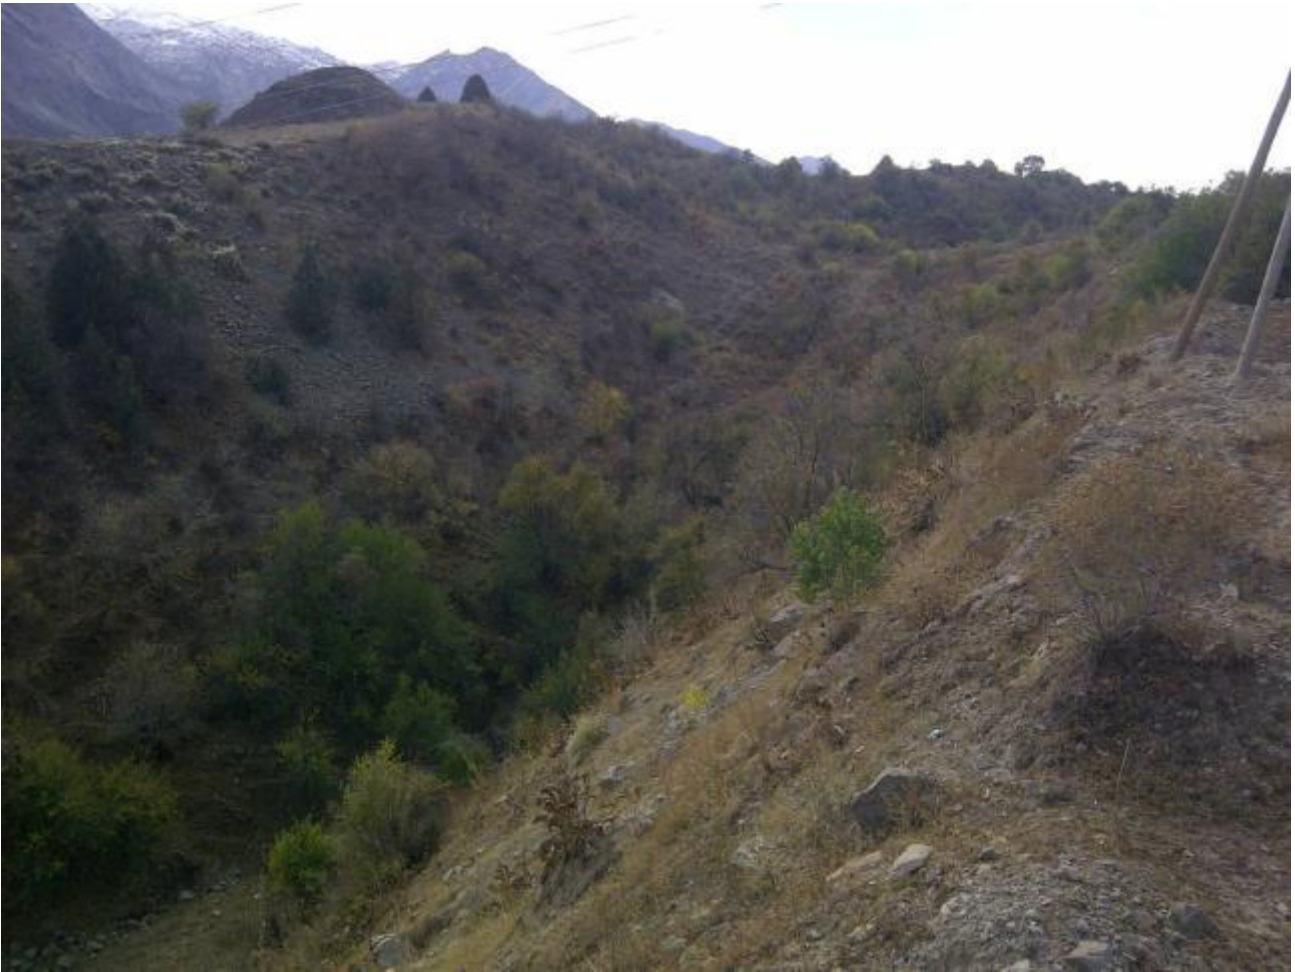
Illustration no.14. Sinkholes elongated parallel to bedding at the eastern part of the high flat.

The morphology of the wide flat area in the RB is complicated by numerous topographic depressions (Illustration no.14). They can be elongated parallel to the bedding, ENE-WSW, but also of round shape. Their width is very variable, from a few meters to more than 100 m. The small sinkholes are very similar to those known in karst areas. The largest ones can shelter permanent or temporary lakes. The one with the permanent lake lies just south of the borehole DZ2. As discussed in the next chapter, this borehole crossed about 65 m of clays which could be interpreted as residual infill of a large karstic sinkhole. The presence of limestone at outcrop and of thick gypsum/mudstone sequence in the borehole suggest that the sinkholes are related to karstic dissolution.

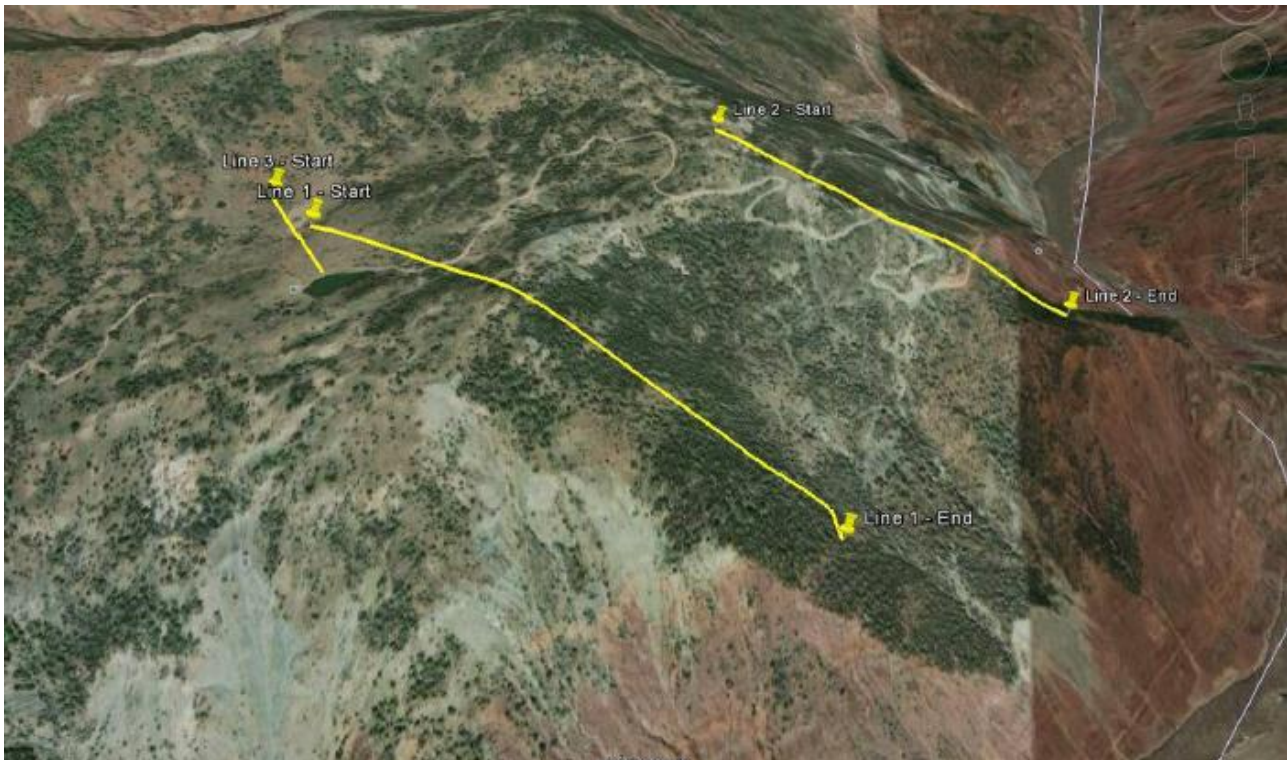
Illustration no.16 Location of the seismic refraction profiles.

Seismic refraction investigations were carried out in order to estimate the thickness of overburden and to approach the characteristics of the bedrock by the variation of elastic wave velocity. The location of the seismic lines is showed in Illustration no.16.

The seismic lines are spread over the flat area and the slope below. Line 1 crosses the central part of the atypical area, running by the location of borehole DZ2. Line 2 runs near the eastern boundary of the atypical zone and near the borehole WRB2/DZ1. Line 3, only 230 m long, brings additional information on the flat area, passing through the location of DZ2.

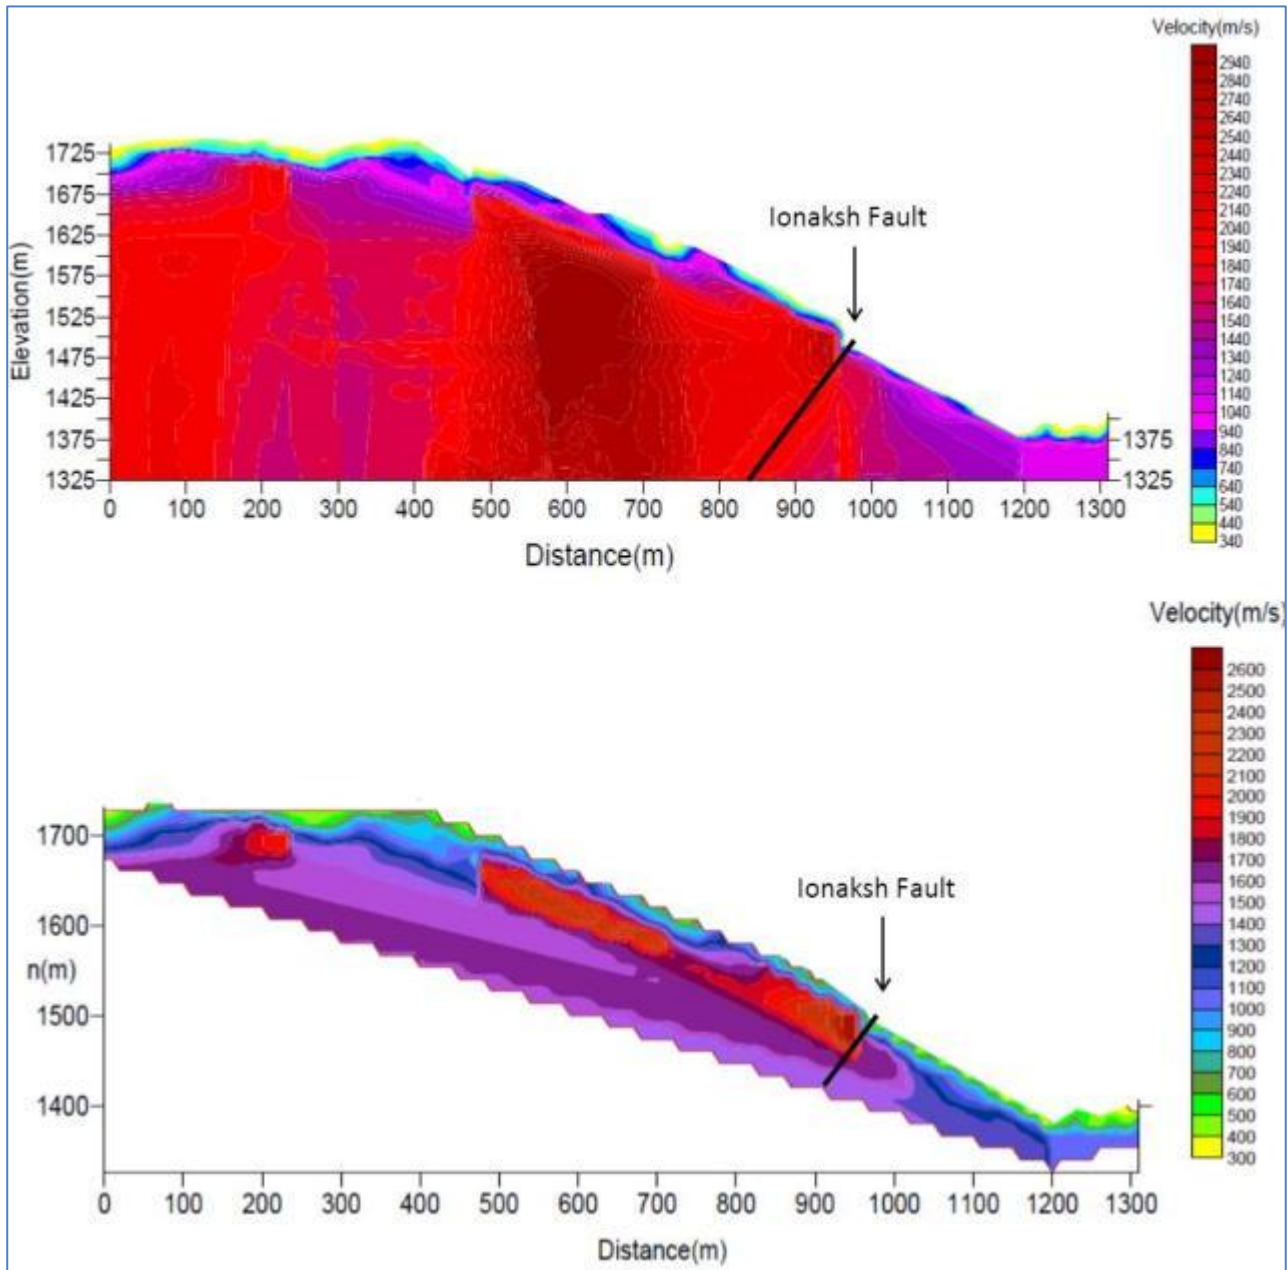
Illustration no.17. Summary of results on Line 1 according to two interpolation methods.

Illustration no.17 presents the summary results for Line 1.

horizons and (ii) downslope, the Lower Cretaceous formations where velocities stay low, in the order of 1200-1500 m/s even at depth.

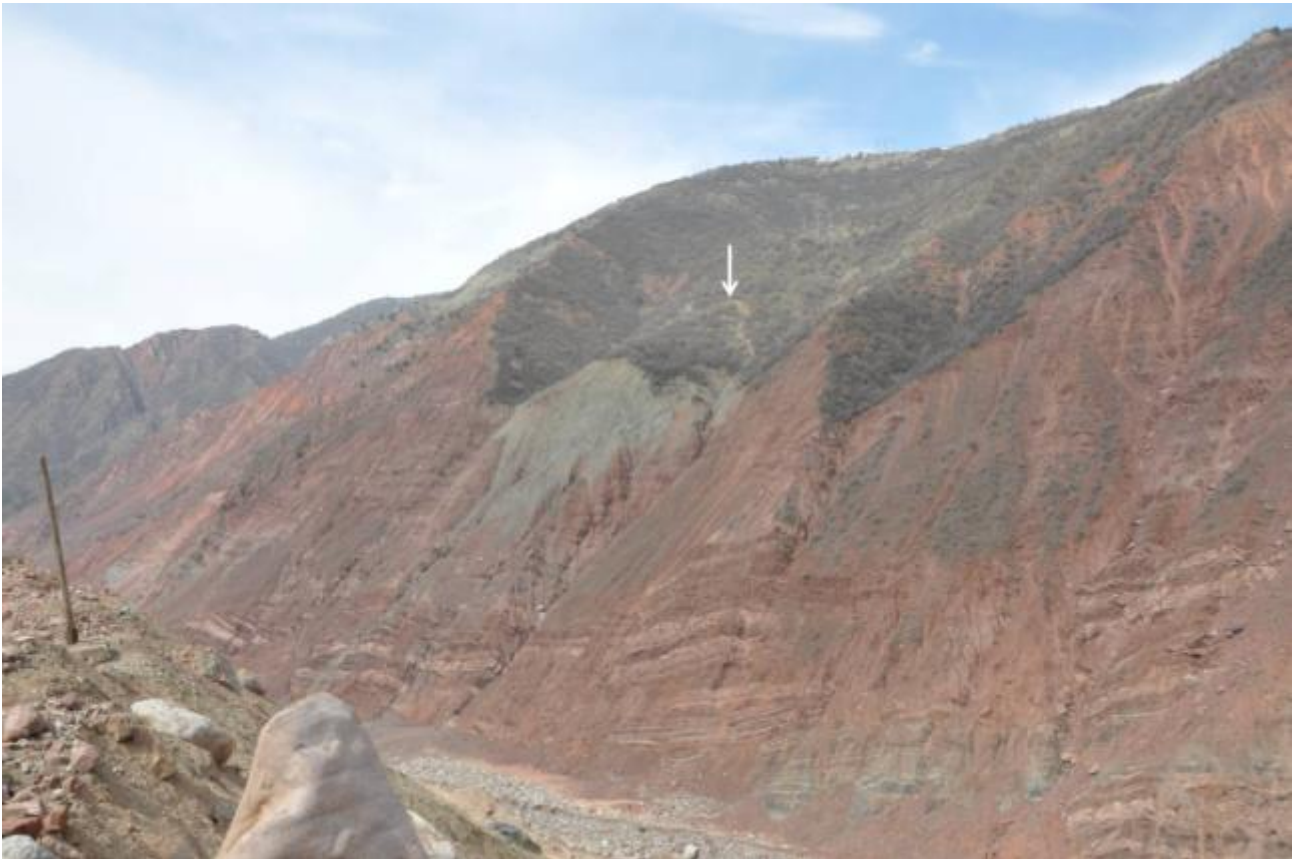
Illustration no.24. Zone of ancient landslide in the central part of the slope. The arrow indicates the crown of recently initiated landslide.

Materials resulting from ancient instabilities are concentrated in the central part of the main slope, below the flat area (Illustration no.24). The field inspection indicated that these instabilities involved principally Turonian shales, the failure of which entrained subsequently the overlying massive limestone. These deposits are expected to evolve progressively in future landslides, as shown already by the crown of the landslide initiated, most probably in the last years, in the frontal lobe. Without mitigation measures, the volume of this next landslide could vary between 100,000 and 500,000 cubic meters. Mitigation measures, such as reshaping of the slope and drainage are recommended and can considerably reduce the risk.
