## **TECHNO-ECONOMIC ASSESSMENT STUDY FOR ROGUN HYDROELECTRIC CONSTRUCTION PROJECT**

### **PHASE 1 ASSESSMENT OF EXISTING ROGUN HPP WORKS**

#### **Annexes**

**Report No. P.002378 RP 39 rev. C**

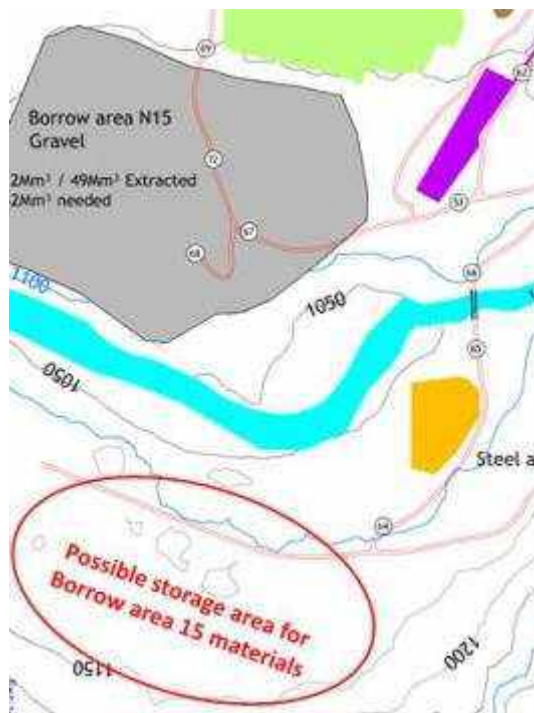
**Figure 6-9: Location of a potential area for storage of borrow area 15 materials**

In order to maintain access to the borrow area, and to avoid any loss of material due to flooding, future exploitation is to be adapted, in order to guarantee that, in every location of the borrow area, all suitable material has been excavated and stored at higher elevation before flooding occurs. This is likely to require an anticipation of the excavation of the lower levels.

A possible solution would be to store the extracted materials on the right bank in front of the borrow area 15, where a relatively flat area, located at higher elevations, would allow avoiding early flooding.

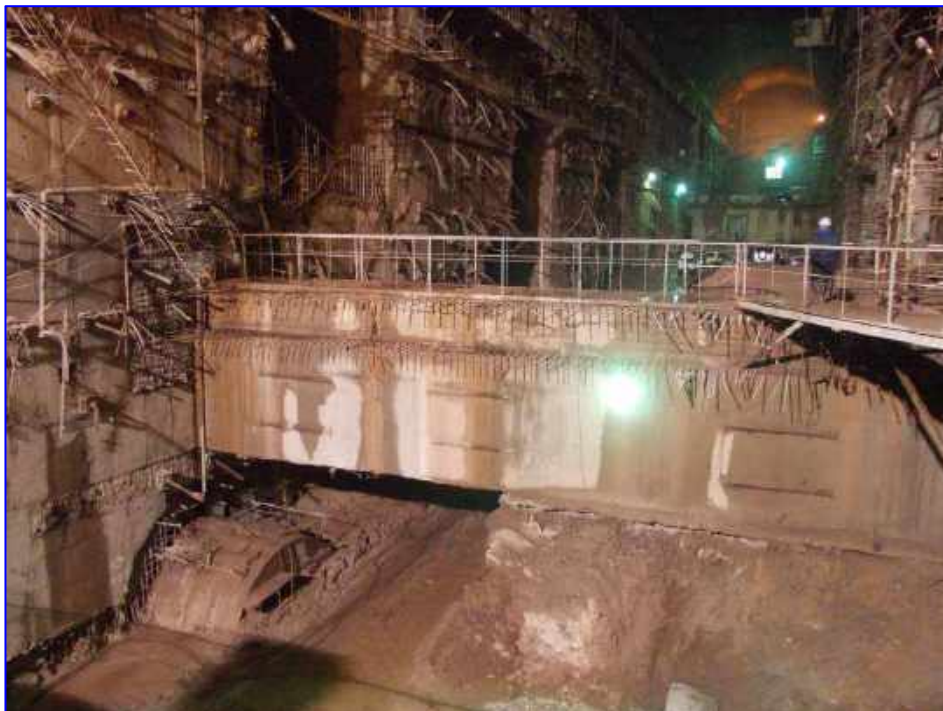
Figure 9: Photograph of reinforced concrete strut 2 between Units 6 and 5 (taken during the site visit of April 4-6 2013)

It is understood that in the meantime, with due consideration and concern given to the significant deformations which developed in the siltstone area, the decision was taken to introduce, as a means to provide protection against further convergence, 6 reinforced concrete struts between elevation 969.2 m and 964.2 m approximately, as shown in Figure 8. These struts were effectively implemented between 2011 and 2012 and excavation down to elevation 958.2 m took place in the area of Unit 6 as visible in Figure 9.

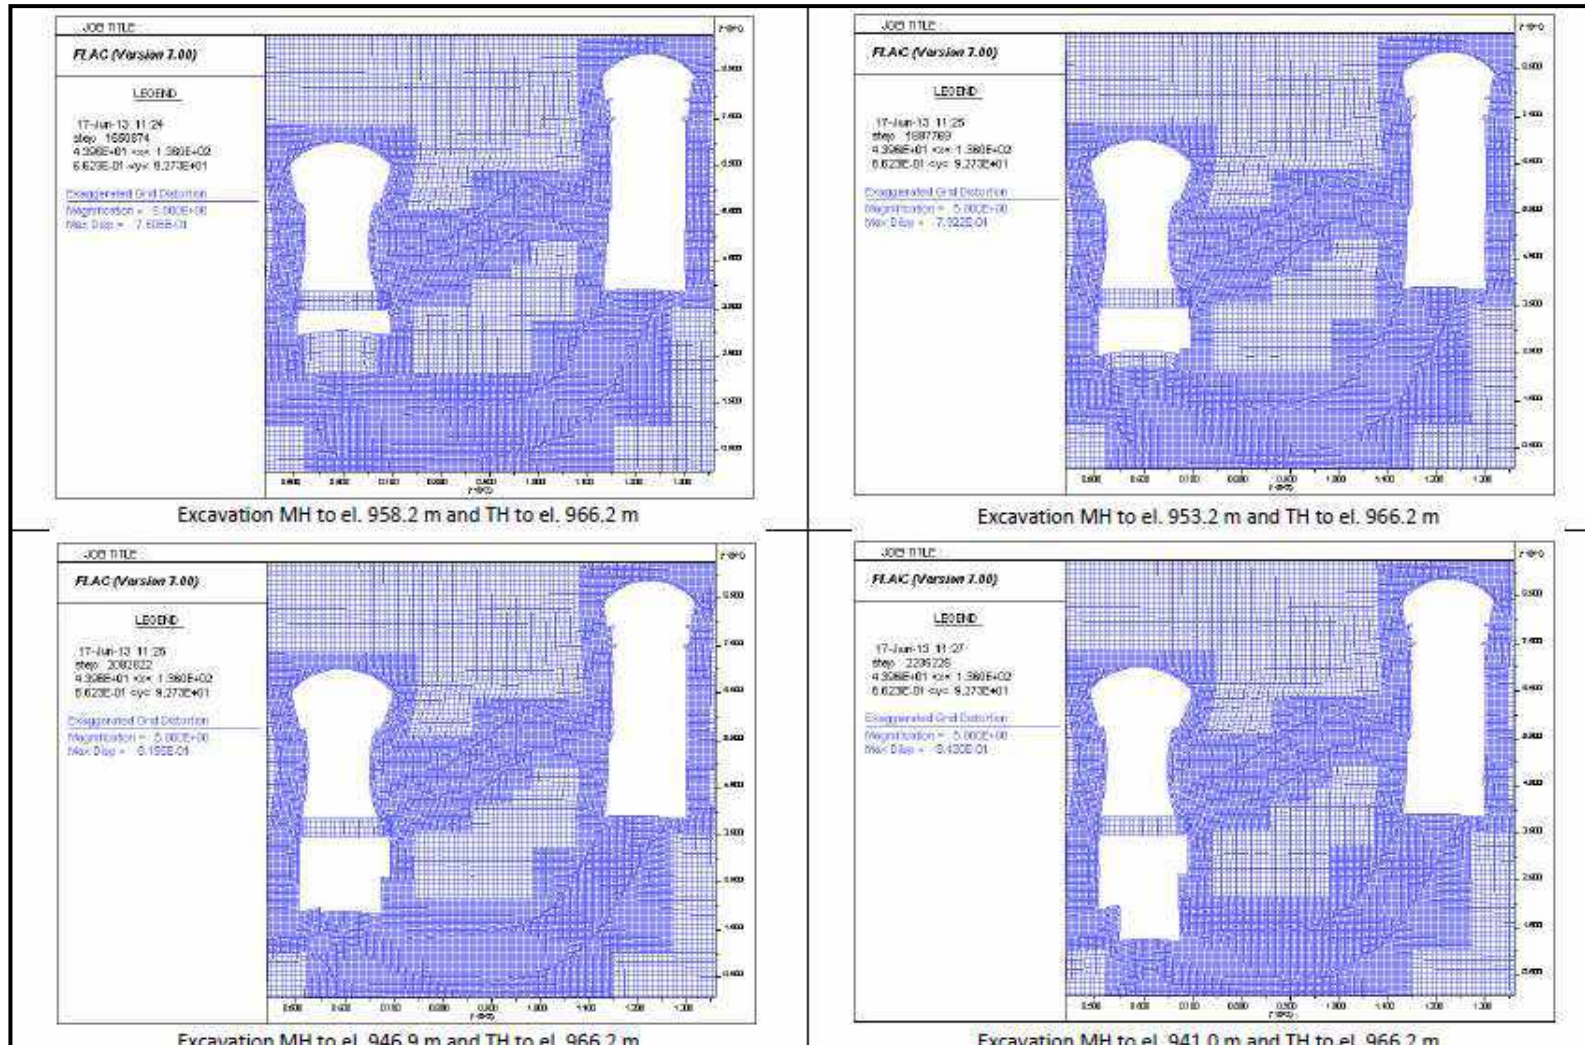
As the excavation is deepened below this level down to the invert of the turbine pit (Figures 39 and 40), the upstream sidewall of the MH cavern deforms dramatically as the reinforced concrete strut starts to bend upwards. It is observed that once again, as failure propagated into the pillar between the two caverns, the TH cavern undergoes deformation and the most significant displacements occur on the upstream sidewall.

Figure 39: Illustration of deformed grid for excavation level in the MH cavern down to 941 m and in the TH cavern down to 966.2 m
