TECHNO-ECONOMIC ASSESSMENT STUDY FOR ROGUN HYDROELECTRIC CONSTRUCTION PROJECT

PHASE II: PROJECT DEFINITION OPTIONS

Chapter 2: Geology

Part A - Assessment of geological conditions

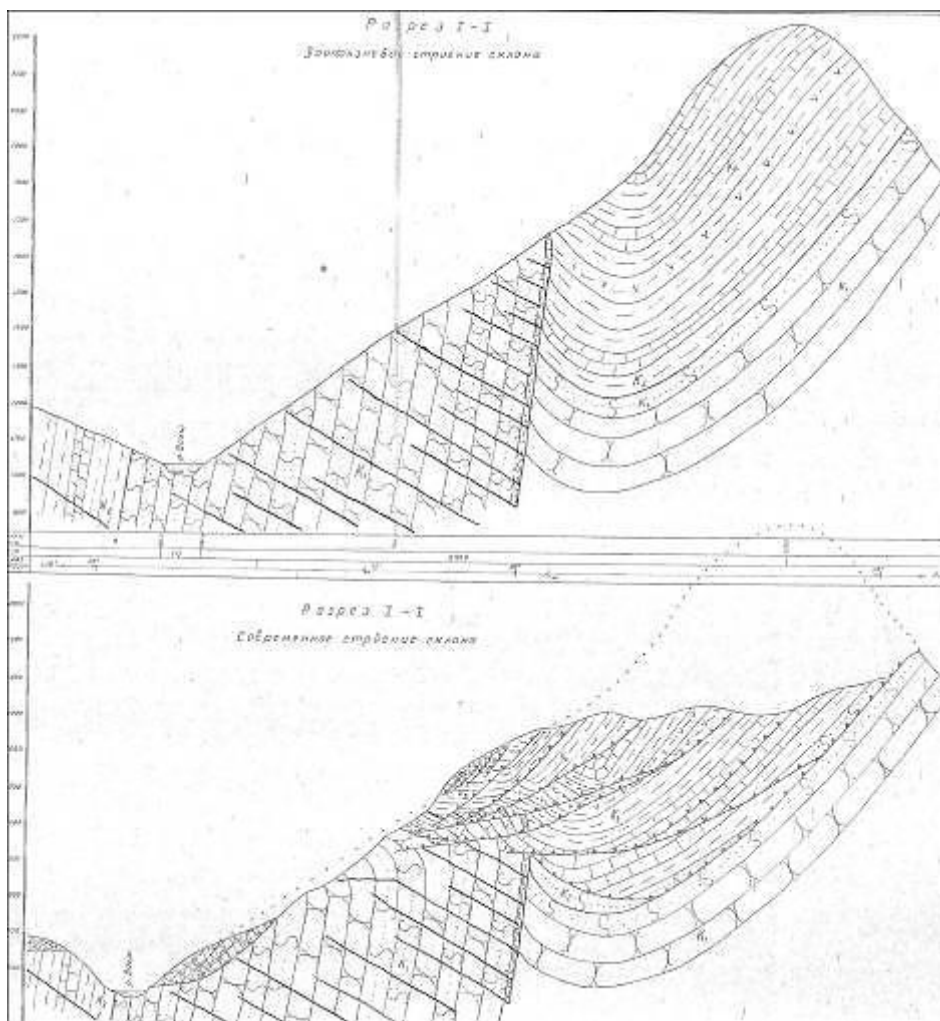
At the Technical Design stage, the particular setting was explained by large scale slope instability, involving successive, massive landslides. While much of the slid rock masses piled up in the upper part of the slope to form the atypical flat area, significant masses also slid down to the river valley. Accordingly, the change of the bedding dip would have resulted from dragging of the layers' heads at the base of the slides (Illustration no. 34). In this 'landslide model', the downslope offset was interpreted as the result of tear-off along the eastern boundary of the landslide zone.

Illustration no. 34. Interpretive cross sections of the ‘landslide area’ (in [1]). View towards downstream (SW). Original setting at the top, post-landslide setting at the bottom.

The Technical Design 1978 report concluded that the ancient landslide zone is mostly stabilized. At present, only superficial landslides could result from failure of deposits from the body of the ancient landslide and from the disturbed layers on the slope. The maximum size of such potential landslide was estimated at ‘a few hundreds of thousands of meters’

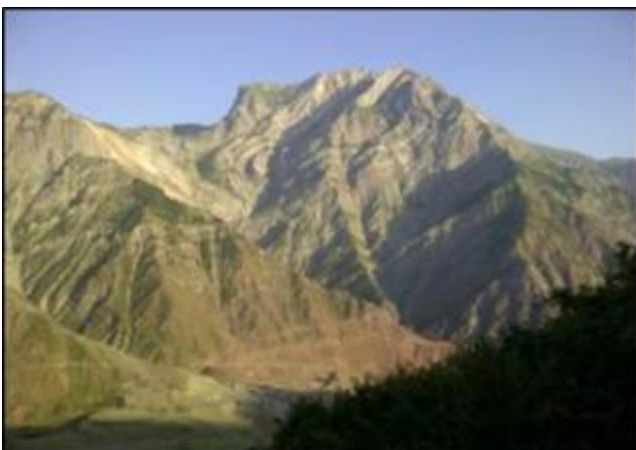
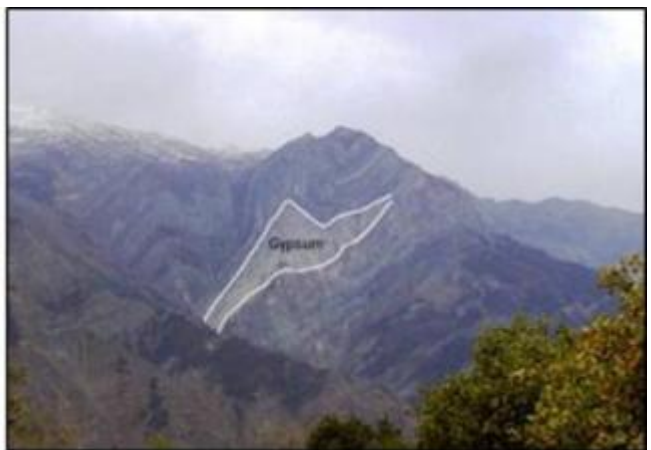
Similar gypsum formations are involved as décollement level in the outstanding bubble wrap folds, typical of salt/evaporite tectonics, which are visible in the opposite bank of the Vaksh River (Illustration no. 36). It is concluded that in the area of the project, the tectonic stresses are accommodated by décollement not only in the Jurassic salt formation but also at other favorable levels above it.

Illustration no. 36. Salt tectonics, bubble wrap folds in the left bank opposite to the atypical area.

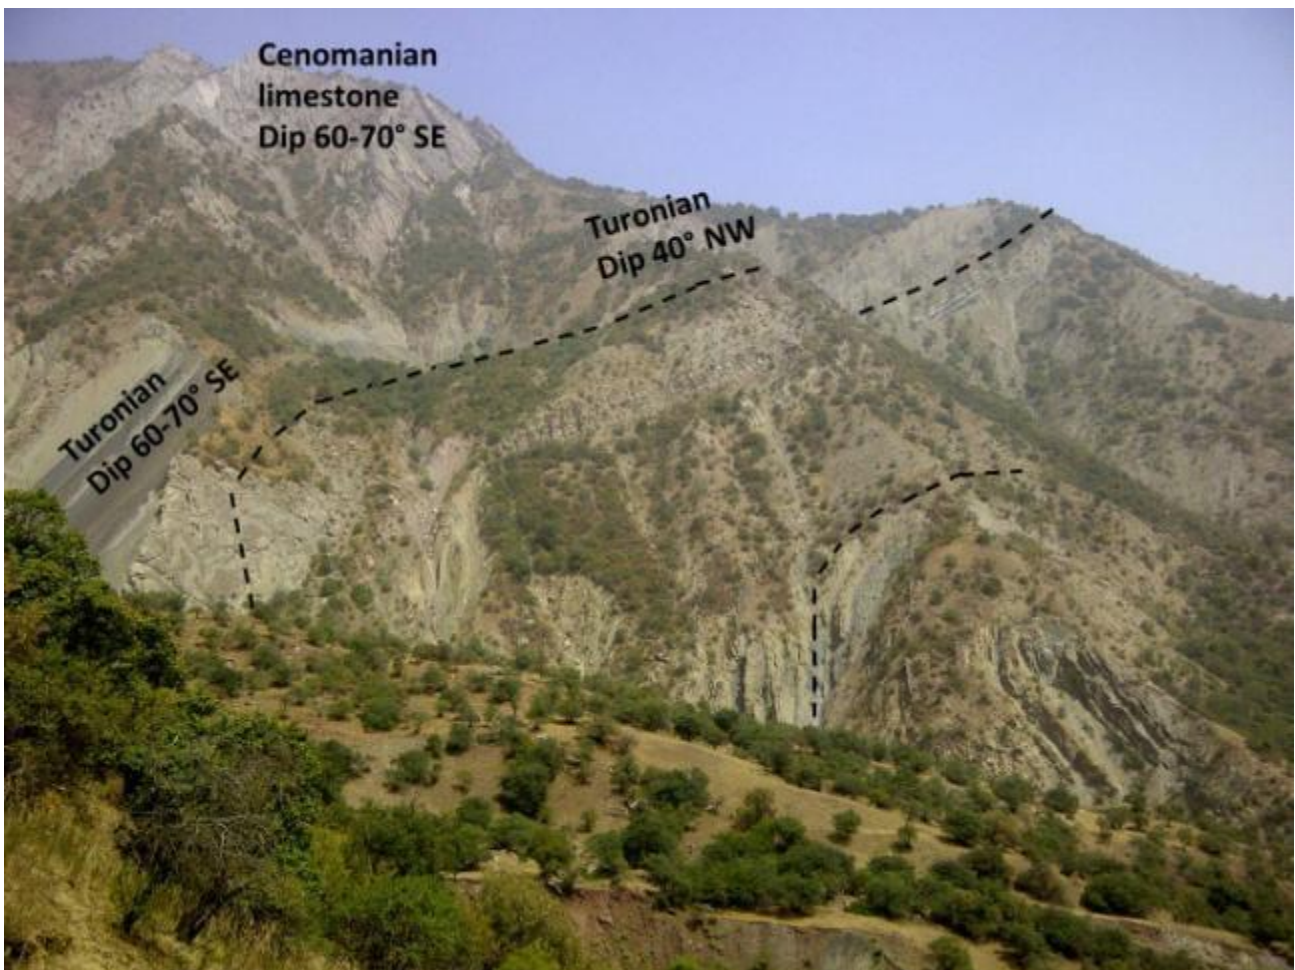
- Large scale folding and overturning of the Upper Cretaceous sequence including Cenomanian and younger formations was directly observed in continuity with the 'atypical setting' which had been formerly interpreted as 'landslide' of Upper Cretaceous layers (Illustration no. 37). The left bank of Ararak stream exhibits large scale bending and reversal of the Cretaceous sequence. Formations are younger from the left to the right. At left, normal position with bedding dip to SE. At right, reverse position with bedding dip to NW. Turonian black shales and massive limestone at the contact Turonian/ Cenomanian, as key beds, can be followed practically without interruption towards the dam site.

**Illustration no. 37. Large scale folding in the left bank of Ararak stream.**

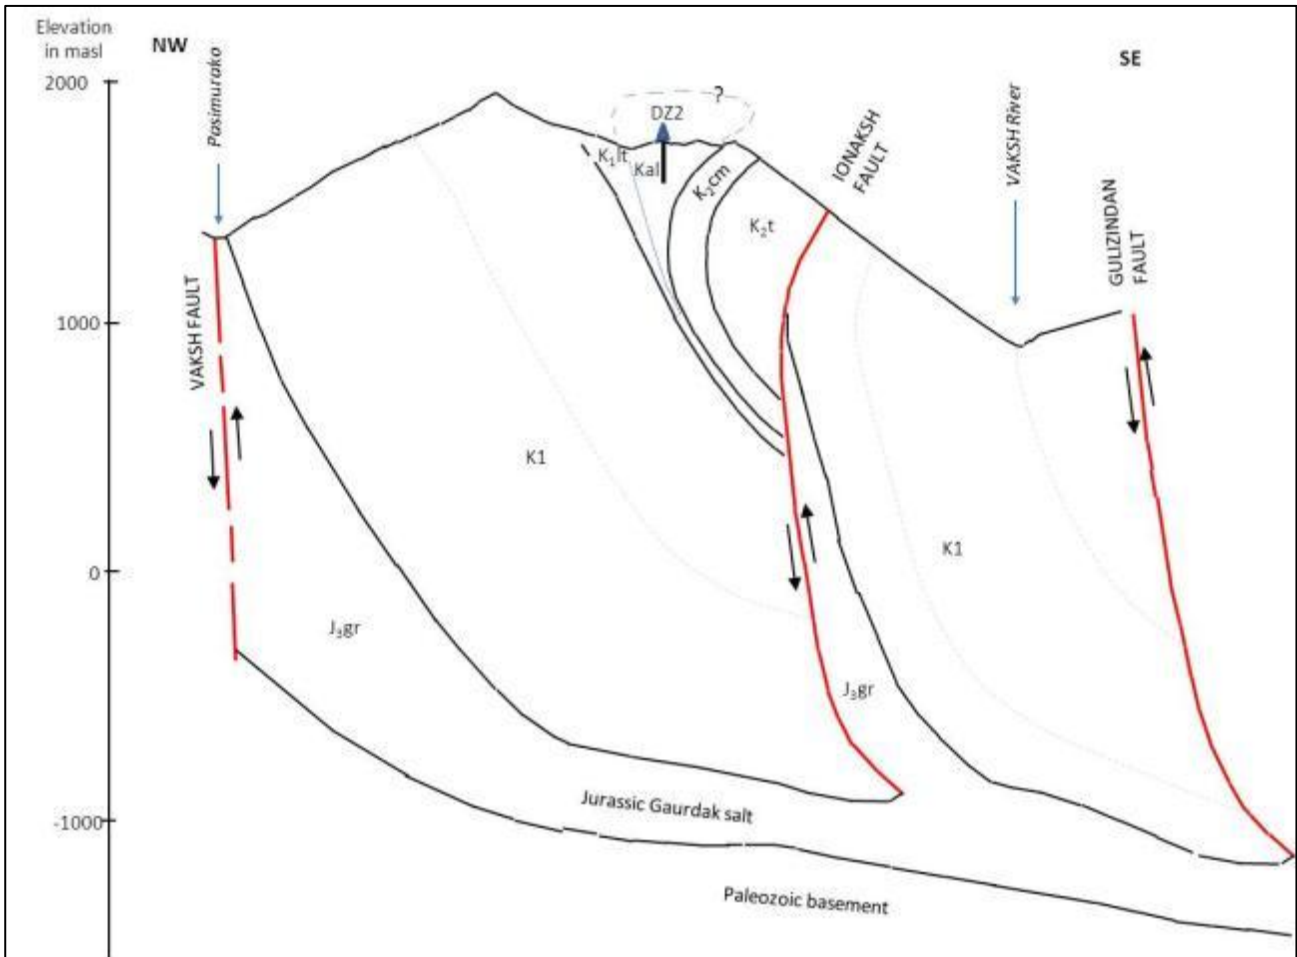
Based on the available, previous and recent data, the geological setting of the atypical zone in the right bank is a result of tectonic deformation, as opposed to successive massive landslides and superficial creeping processes. The tectonic deformation could be related with décollement at evaporite layers located within the Upper Cretaceous sequence. One possible interpretation of the field observations is proposed in Illustration no. 39.

Illustration no. 39. Right Bank interpretive cross section, view from the SW.

This interpretation cannot pretend to reproduce accurately the reality, considering the complex setting and the paucity of the subsurface investigations. Nevertheless, it integrates field evidence of complex folding at large and at small scale, putting forward the model of tectonic deformation to explain the geological setting of the atypical area.

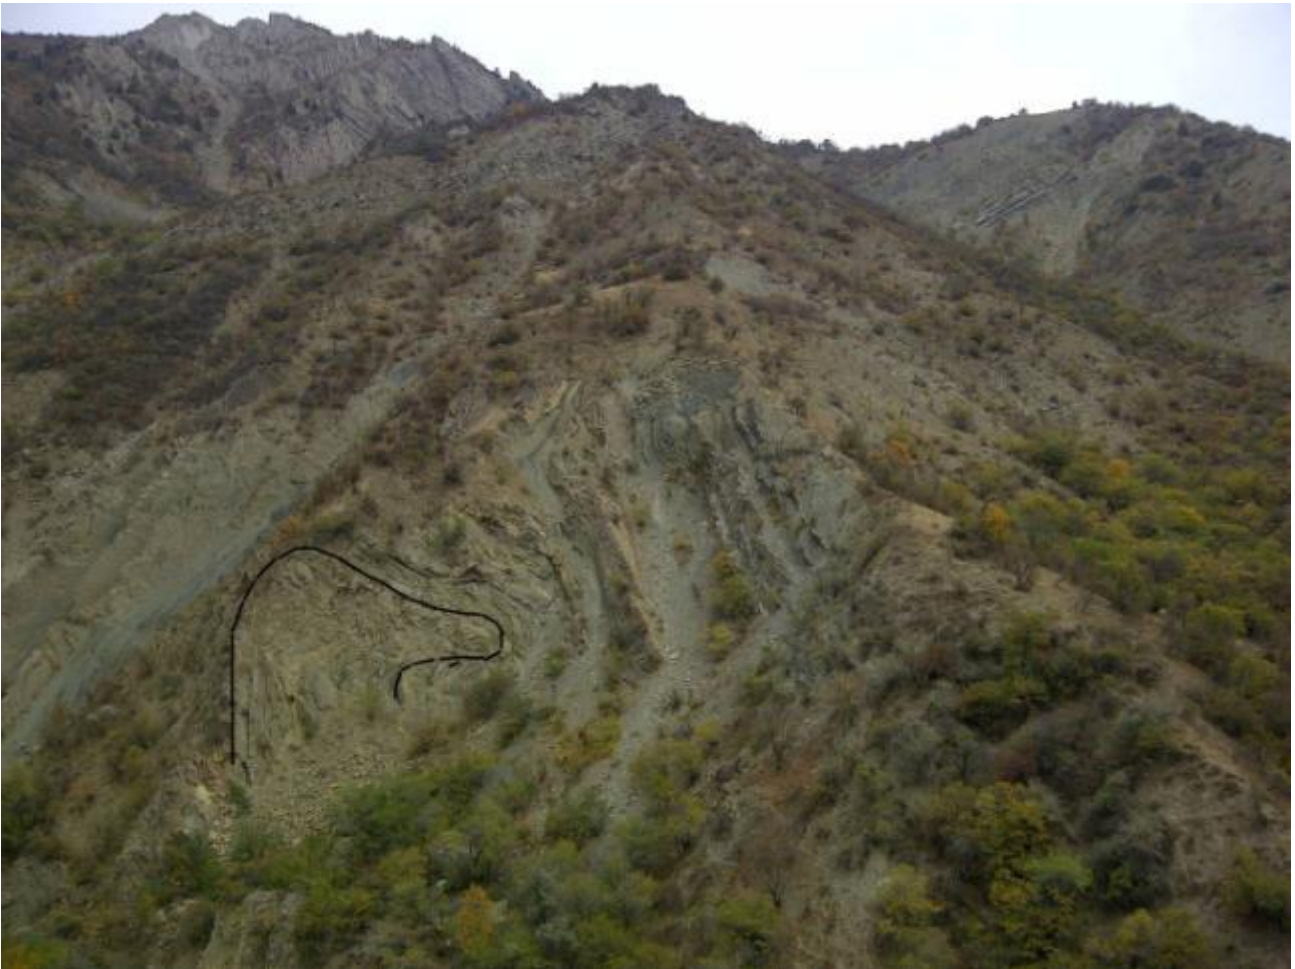
Illustration no. 40 below shows, at small scale, a tight asymmetric bubble wrap fold the core of which is very similar to the fold core in the interpretive section.

Illustration no. 40. Left bank of Ararak stream. Tight folding in Coniacian layers.

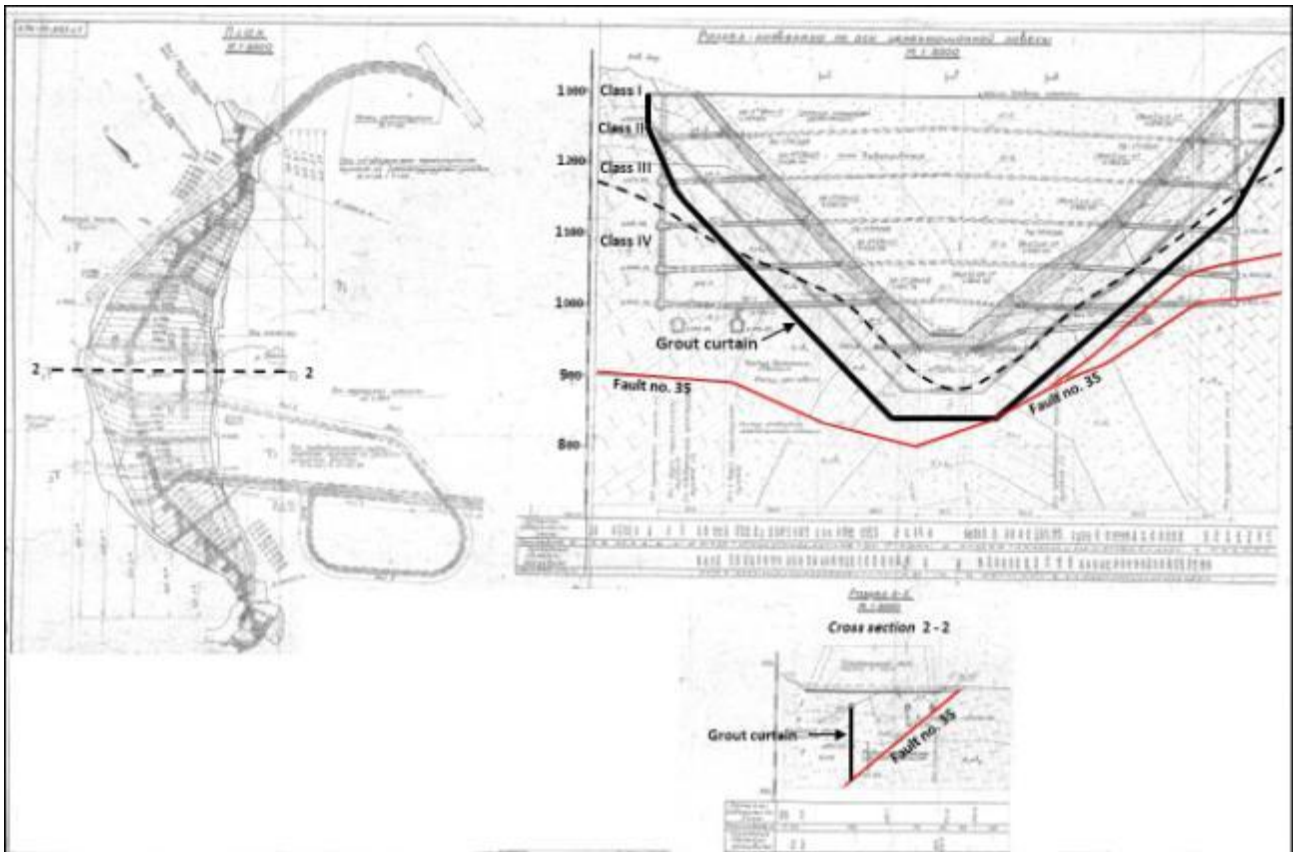
The impervious core is located judiciously in the mudstones of the Lower Obigarm formation. This thick sequence of mudstone layers has naturally low permeability, in particular in the Class IV type of rock mass. For this reason, the proposed depth of the grout curtain (Illustration no. 41) seems, at this stage, adequate. On the contrary, it is estimated that the lateral extent, especially in the Right Bank, cannot be designed before determining the characteristics of the boundary of the atypical zone and carrying out additional permeability tests.

Illustration no. 41. Grout curtain extent (in [1]).

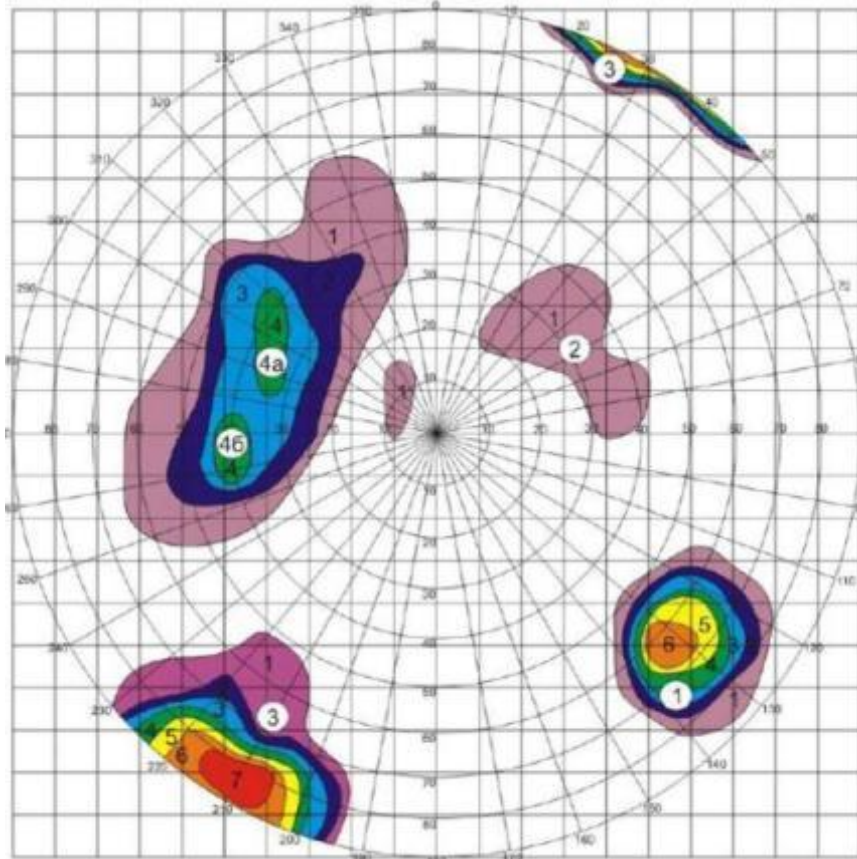
The joint orientation data was recorded in the branch excavated from station 0+287 of gallery #1030, with azimuth 226° and a length of 10 m. The following synthetic joint plot (Illustration no. 42) is based on 718 readings.

Illustration no. 42. Joint pattern plot in siltstones of Lower Obigarm formation.

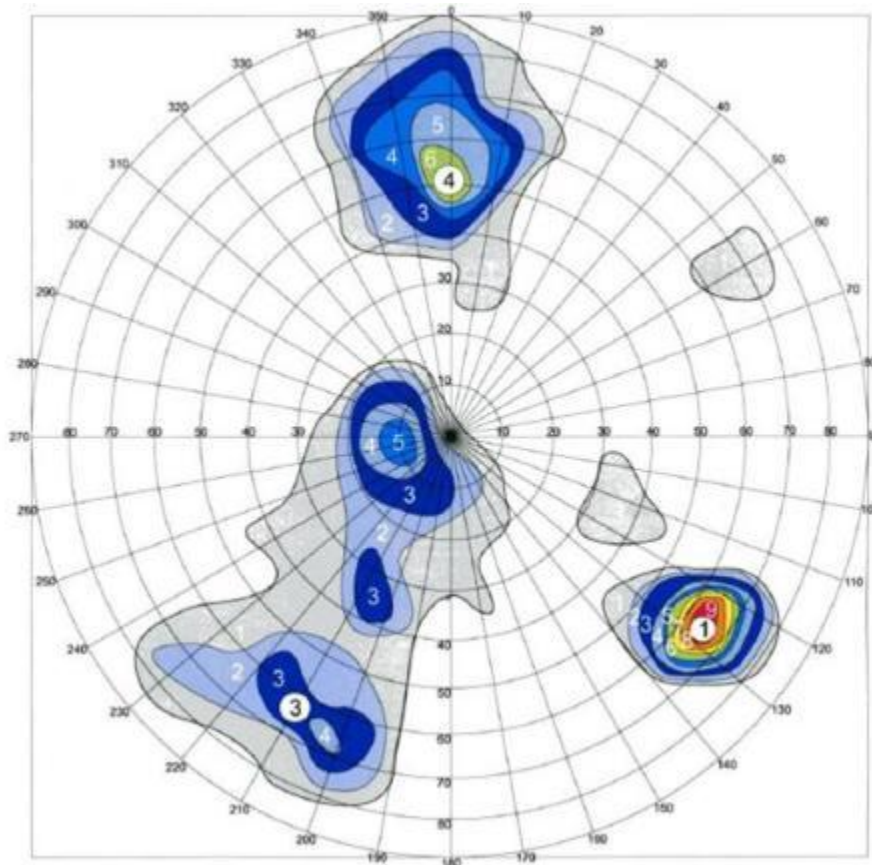
The data was recorded in the branch excavated from station 0+540m of gallery #1030, with azimuth 223° and a length of 10 m. The synthetic joint plot (Illustration no. 43) is based on 372 readings.

Illustration no. 43. Joint pattern plot in sandstones of Upper Obigarm formation.

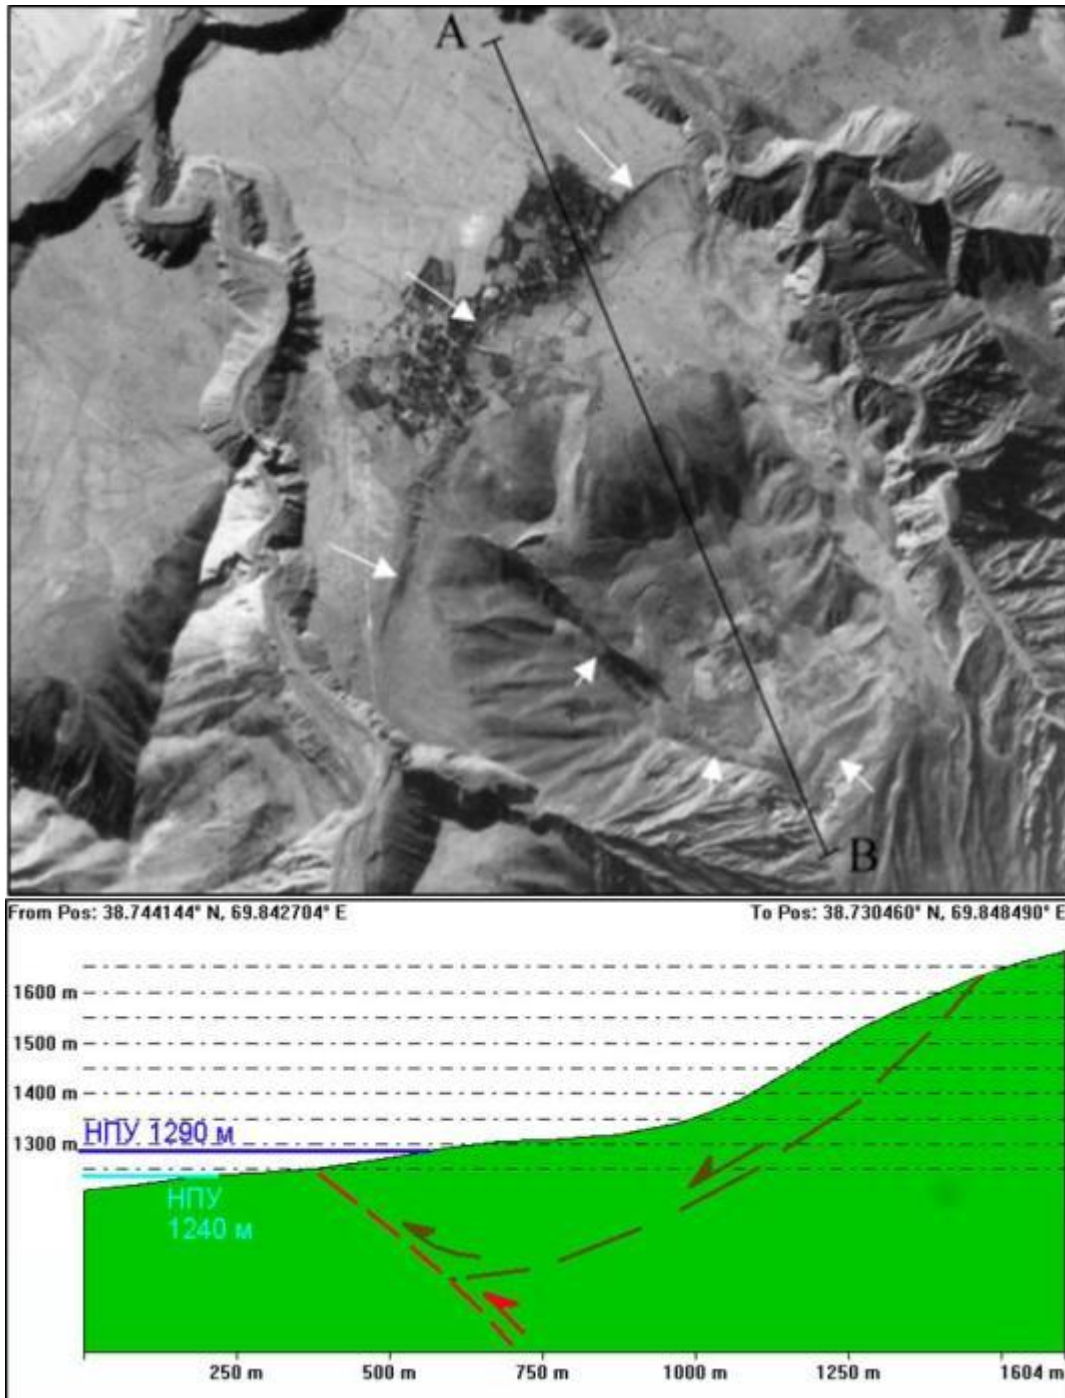
- between Tagikamar and Khodzhaalisho streams, a 15-20 m high scarp has been interpreted as outburst of a basal surface of a large rockslide, the slope above the scarp showing features of anomalous displacements. The frontal part of the slide would coincide with the thrust fault plane (Illustration no. 47). Long arrows indicate the thrust bench, short arrows indicate sliding features. Interpretive cross section AB is presented in the lower part of the illustration. The analysis concluded that the rockslide, with a volume roughly estimated at 10 to 15 million cubic meters, could be (re)activated as water level rises above elevation 1250m.

Illustration no. 47. Recent thrust and assumed landslide near the foot of the Vaksh Ridge between the Khojalisho and Tagikamar valleys (grouped figures from [11]).

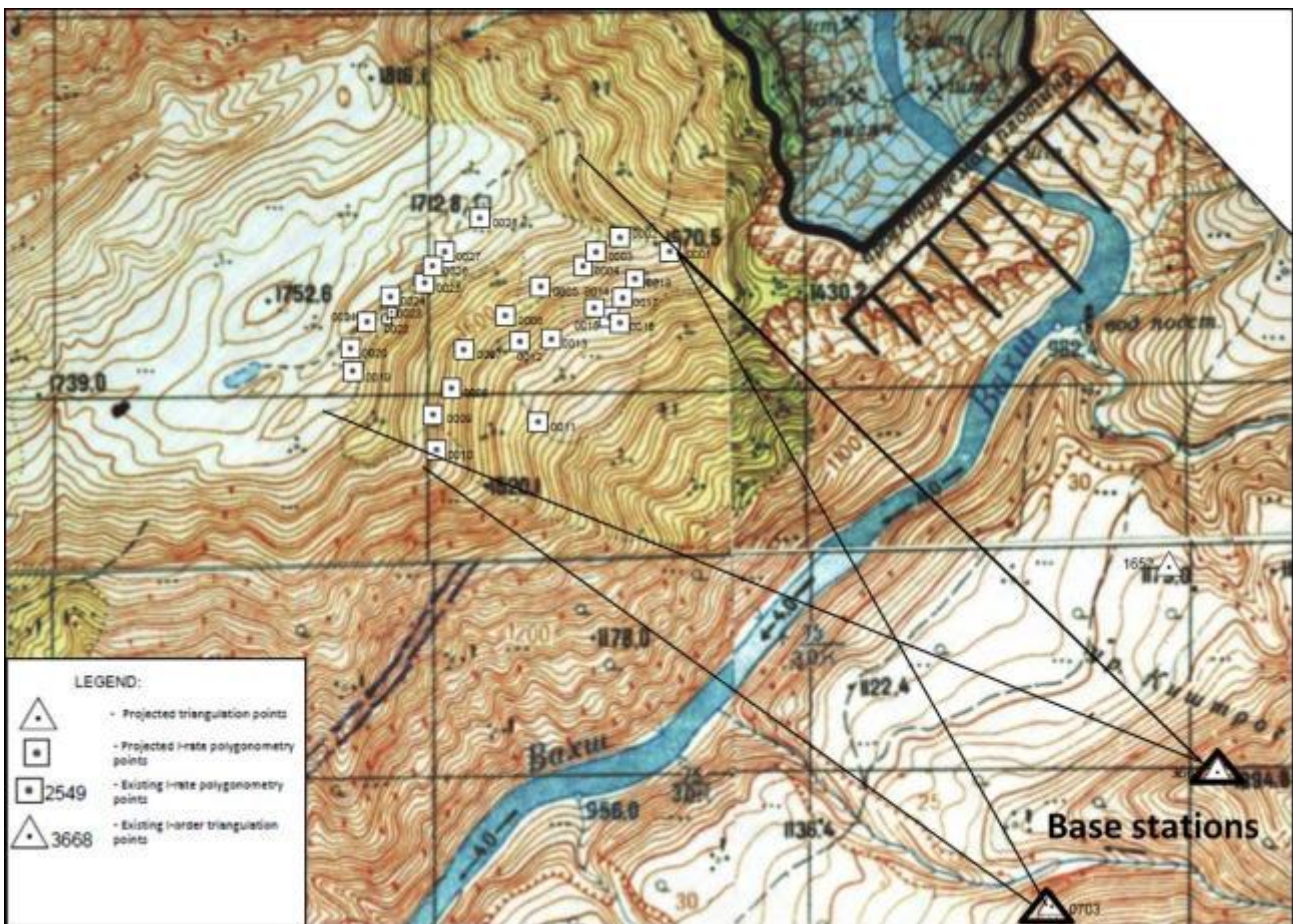
In order to detect and follow-up any slope movements in the atypical zone, 30 geodetic stations have been installed (including three older stations which have been rehabilitated). The targets have been scattered on the upper part of the slope below the plateau. Readings will be performed from 2 base stations located on the opposite bank (Illustration no. 51).

Illustration no. 51. Location of the geodetic monitoring system.
